Fretting and Corrosion between a metal shell and metal liner may explain the high rate of failure of R3 modular metal on metal hips

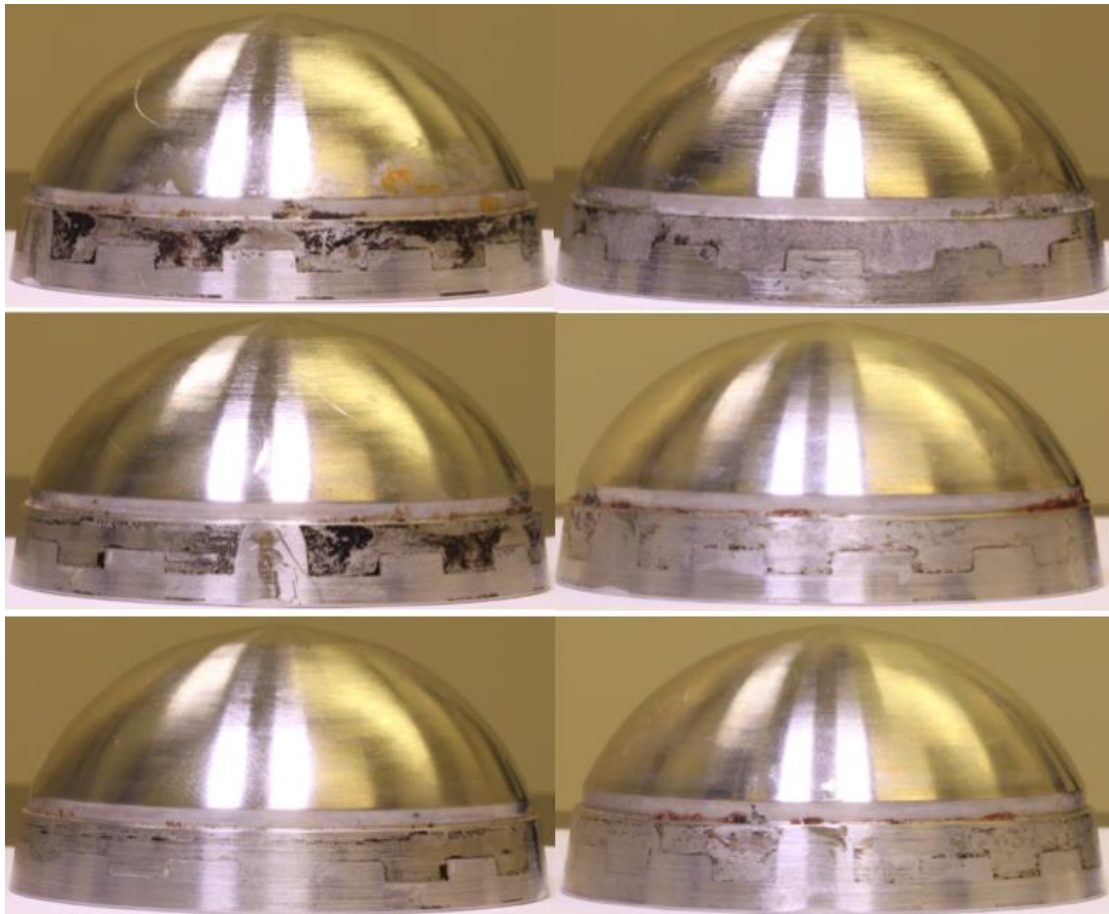
Visual analysis of each acetabular shell showed a band of debris on the inner surface, below the hard-bearing taper locking mechanism. The backside of the R3 metal liners illustrated evidence of surface damage and black debris in the same area. The areas of corrosion were clearly demarcated into a 'castle parapet' shape (figure 1). These areas of corrosion were found circumferentially at the equator of the metal liner. SEM micrographs of the backside of the liner illustrated evidence of pitting within the areas of corrosion and confirmed that the corrosive damage was clearly within the boundaries of the 'castle parapet' shape (figure 2). EDAX confirmed corrosive debris, rich in titanium (figure 3)

The corrosion on the backside of the retrieved metal liners in this study appears to have a clear pattern. Micrographs highlighted that there was a clear border as to which areas were corroded. These areas are exactly matched to corresponding areas on the inner surface of the shell illustrating that the geometry of the R3 acetabular shell does not fully conform to the metal liner. The R3 polyethylene liner is different to the ceramic and metal liners as it has anti-rotational tabs to prevent torque and allow a lock fit with the grooves on the acetabular shell. The insertions for the polyethylene tabs are visible on the inner surface of the R3 acetabular shell (figure 4). The metal liner does not have anti-rotation tabs therefore having intermittent areas of contact between the shell and liner at its equator. Where there is close contact between two different metals there is potential for corrosion. The acetabular shell is constructed from titanium, whereas the liner is constructed from a cobalt chromium alloy. The mixing of different metals permits galvanic corrosion and studies have shown that there is increased damage at taper junctions in mixed alloy implants[16-20]. When a metal liner is used in the R3 acetabular system, due to the anti-rotational tabs insertions on the equator of the shell it can permit joint fluid and debris to infiltrate the crevices between the liner and shell. This can cause an exacerbation of corrosion at this taper junction.

Figure 1: Photographs of 6 retrieved metal liners used in the R3 acetabular system illustrating a distinctive pattern of corrosion on the backside of the liners

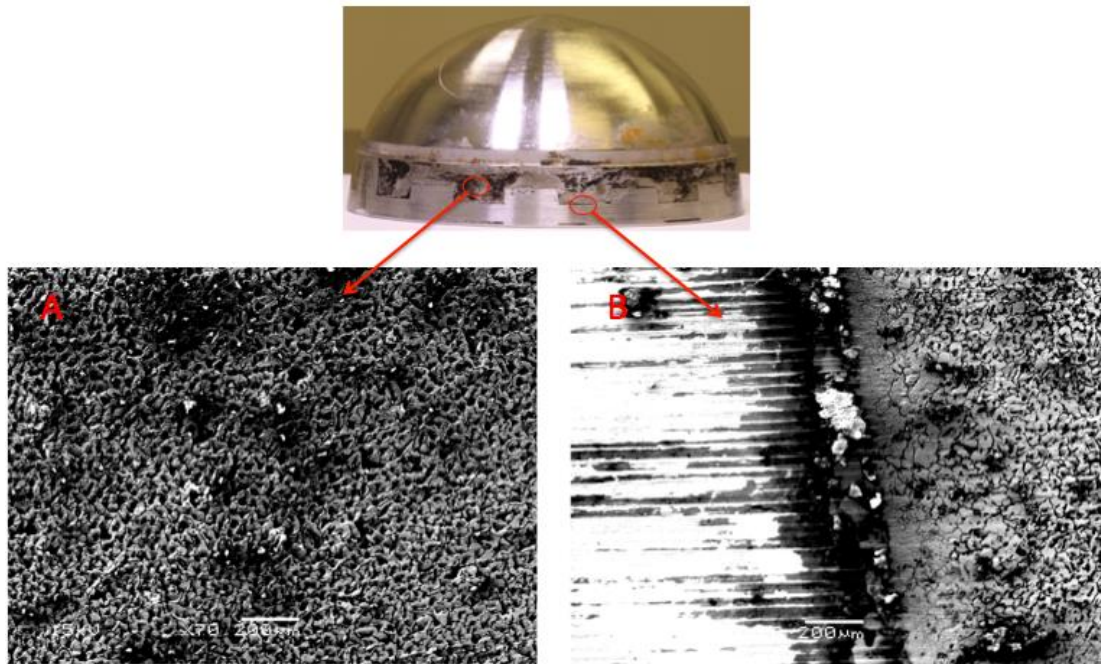
When a metal liner is used in the R3 acetabular system there are areas between the grooves on the shell and the backside of the liner that are in close contact. This area of close contact between the dissimilar metals can create a crevice and a subsequent galvanic environment. SEM imaging showed evidence of pitting within areas of corrosion, which is suggestive of crevice corrosion. Differences in

Figure 2: [A] Scanning electron microscopy image [x70] illustrating extensive pitting in areas of corrosion on the backside of the metal liner. [B] Scanning electron microscopy image [x70] illustrating a clear demarcation between the corroded [right of image] and non-corroded areas [left of image].

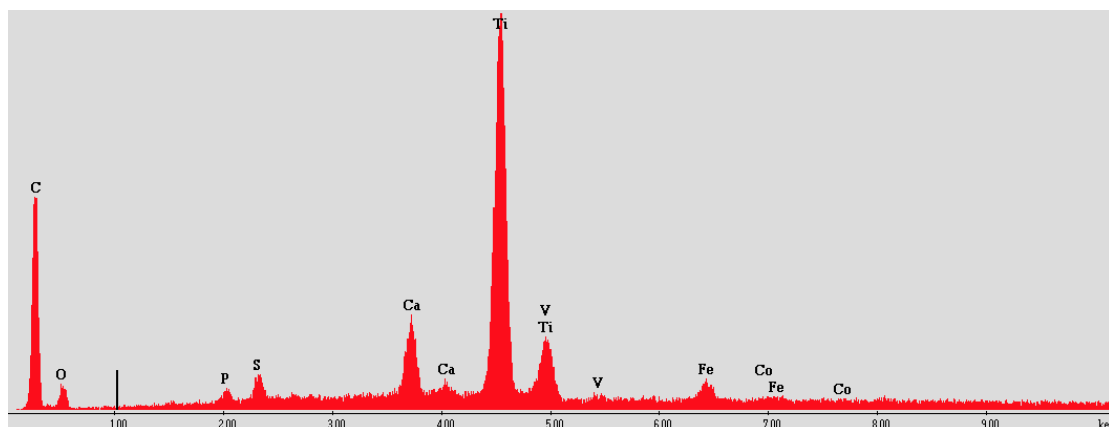
Figure 3: Energy dispersive X-ray spectroscopy of corrosive debris on the backside of the metal liner showing titanium rich deposits

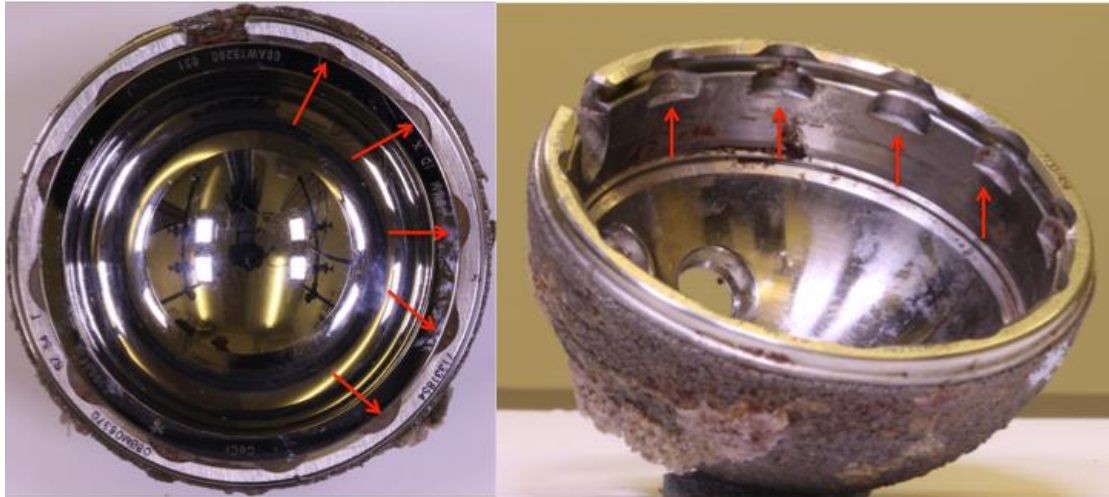
This study has shown that the issue regarding the R3 acetabular system and its metal liner is due to the geometry of the inner surface of the shell. Whilst allowing for anti-rotational tabs of the polyethylene liner, this appears to permit corrosion between the metal liner and shell, leading to corrosive damage of the backside of the liner. The modular design of the R3 acetabular system is not suited for the metal liner and future designs of modular acetabular systems should take these findings into account.

Figure 4: Photograph [100mm lens] of the R3 acetabular shell highlighting the insert for the polyethylene liner anti-rotation tabs [arrows]
