PERFORMANCE OF ROAD BRIDGES DURING THE 14 NOVEMBER 2016 KAIKŌURA EARTHQUAKE

**Alessandro Palermo¹ Royce Liu^{2,3}, Adnan Rais³,
Brandon McHaffie³, Kaveh Andisheh³, Stefano Pampanin⁴,
Roberto Gentile³, Iolanda Nuzzo³, Mario Granerio³,
Giuseppe Loporcaro³, Chris McGann⁵ and Liam Wotherspoon⁶**

ABSTRACT

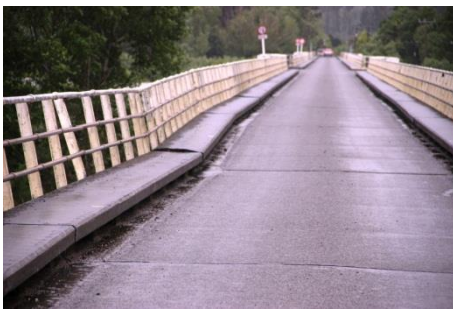
Damage sustained by the Waiau River Bridge was moderate, with the bridge being operated under speed restrictions. The second and third spans of the bridge on the west side was observed to have been rotated in plan view (Figure 8c). This was clearly visible from the closed expansion gaps at pier 3

(c) Rotation of span 2 and 3

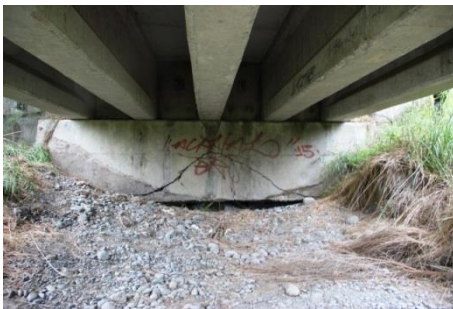
(d) Cracks and rotation on the western abutment

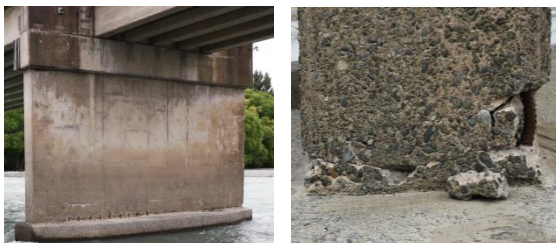
(upstream side), which showed slight signs of transverse rotation towards the upstream side. However, there was no sign of localized pounding damage despite the residual deck displacements. Also, the abutments showed signs of rotation along with some soil subsidence; pile exposure was observed at the eastern end and extreme abutment cracking at the west end of the bridge (Figure 8d) Most piers showed cracks at the pier-pile cap interface with some minor spalling, while at some piers near the waterway, longitudinal bar exposure and buckling was observed as well (Figure 8e)

(e) Cracking and buckling at the base of pier

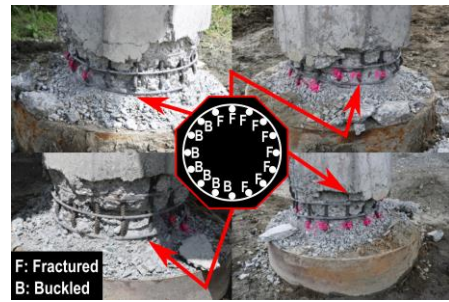
(a) Plastic hinge zone and fractured bars – Lower Mason

The Lower Mason and Lottery River bridges suffered similar damage. Observed damage common to both bridges included: damage to the knock-off block at the central pier movement joint (Figure 13a); failure of the abutment knock-off blocks; residual displacement of most of the elastomeric bearing pads at the piers and abutments; and residual displacements at the central pier and abutment movement joints. Unseating of the deck beams only occurred at the Lower Mason River Bridge (Figure 13b), where, at each abutment one deck beam (on opposite sides) was observed to be unseated off the supporting elastomeric bearing. The piers suffered extensive damage at both bridges, where all piers except the central one formed fully developed plastic hinges at the base. Extensive cover spalling, and a significant number of buckled and fractured longitudinal bars were seen at the Lower Mason River Bridge (Figure 10a and 11). Pier damage at the Lottery River Bridge was similar but there was no evidence of bar fracture (Figure 10b).

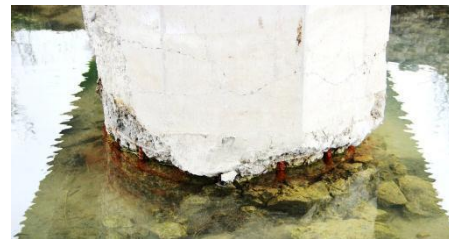
(b) Plastic hinge zone - Lottery River

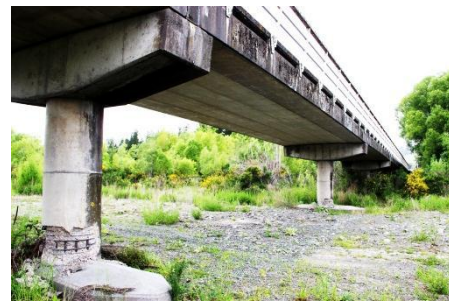
(c) Plastic hinges in piers - Mason River

Similar damage observations were made for the Mason River Bridge, where the deck joints had opened or closed, and pier plastic hinges with bar buckling and concrete spalling were observed with increasing degree of damage towards the centre pier (Figure 10c). The pier damage pattern was interesting at this bridge as concrete spalling and rebar exposure occurred mainly on the south side of the piers (transverse loading direction) and tended to be more in the longitudinal loading direction close to the abutments.

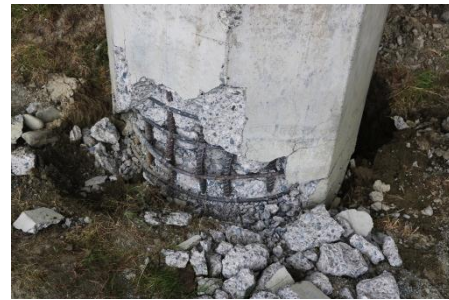
(d) Plastic hinge and spalling - Wandle River

Extensive damage was observed to the Wandle River Bridge (Figure 12) which included: separation between the hollow core deck units at the south end of the bridge; translation of deck units in the downstream direction; hinging and rotating of piers towards the upstream side (in the direction of increasing radius of curvature); opening of the deck joints at the abutments, along with significant approach damage (Figure 10d and 10e).

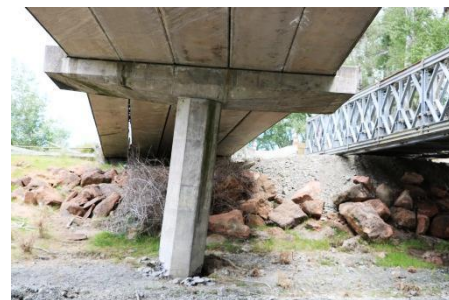
(e) Tilting of pier - Wandle River

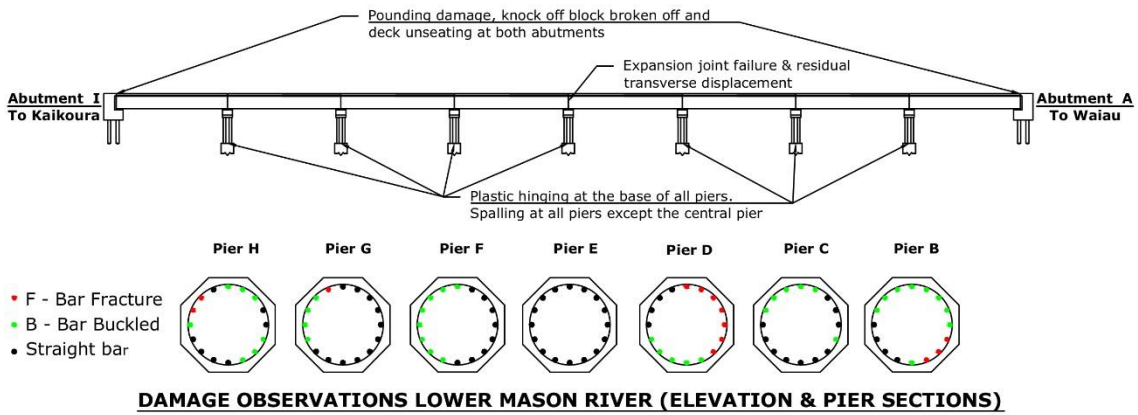
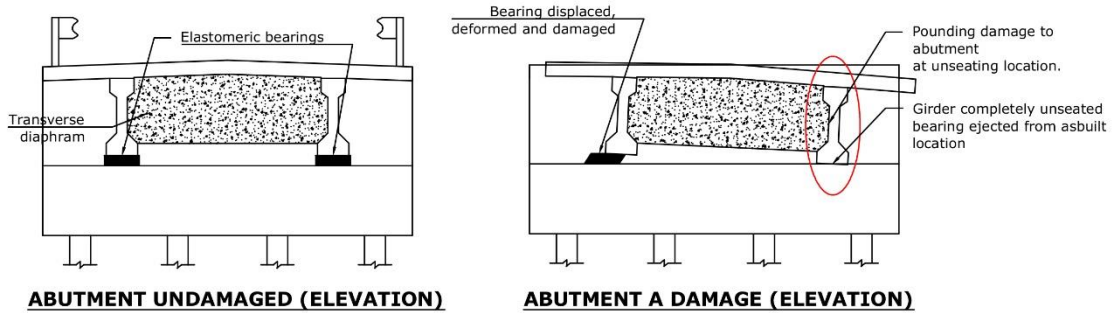
Figure 11: Damage schematics for the Lower Mason River Bridge.

The preliminary performance analysis on the Lower Mason River and Lottery River bridges indicates that both bridges were highly loaded both in the transverse and longitudinal directions with the damage level exceeding the life safety performance limit causing the piers to develop plastic hinges in all piers with less severe hinging observed at the central pier of the Lower Mason bridge. All of the knock-off devices at the movement joints were damaged. It is probable that the knock-off blocks at the abutment movement joints failed first, increasing the displacement demand of the bridges and creating pounding of the abutments. This was probably followed by failure of the central movement joint. Finally, this situation led to an asymmetric unseating of the beams from their bearings at the abutments of the Lower Mason Bridge. Bearing movement was observed at the Lottery River Bridge, but, no unseating occurred. Also, the abutments were subjected to lateral spreading of the soil and probably some slight settlement.

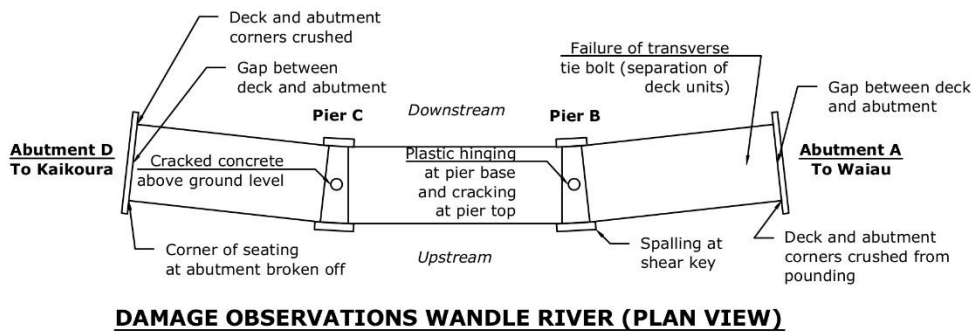
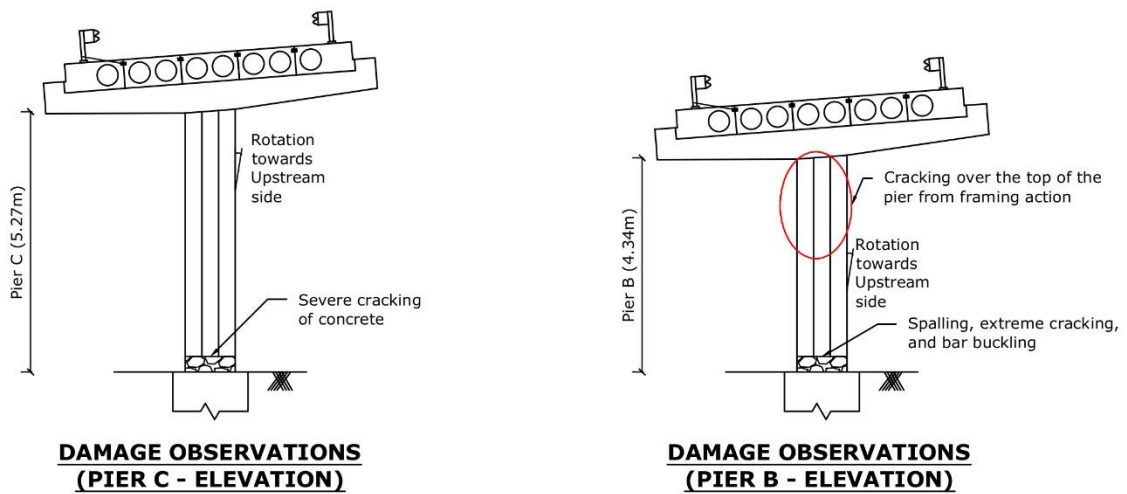
Figure 12: Damage schematics for Wandle River Bridge.

The same conjectured response can be extended to the Mason River and Wandle River bridges, as most of the damage was purely due to ground shaking. The piers performed well, as they developed plastic hinges at the pier bases and went through the expected failure mechanism. However, significant instability was visible in the curved Wandle Bridge, where most likely all orthogonal motions were interacting with the bridge structure, causing large displacements (leading to probable failure of transverse tie-rods, if present) and separation gaps between some of the deck beam units. It is also believed that the excessive residual tilt of the piers is not only due to plastic hinging but may also result from the asymmetric transverse stiffness (from the curved plan layout),

causing ratcheting in the structure. The layout results in greater transverse stiffness in the downstream direction due to arching action between the abutments, relative to the upstream direction, where the bridge is only restrained by linkage bars at the abutments; leading to hinging and residual tilts towards the less stiffer upstream direction. Additional contribution to the tilt may also be possibly due to failure of the foundations due to the pier piles being quite short. However, the piles are founded in rock so residual displacement from the piles was probably small.

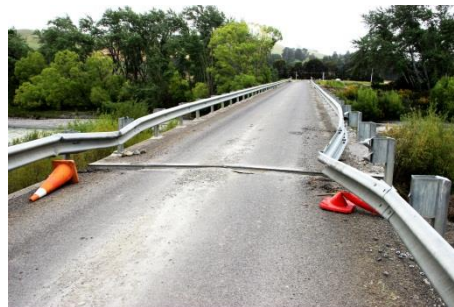
(a) Compression failure of the expansion joint over the central pier

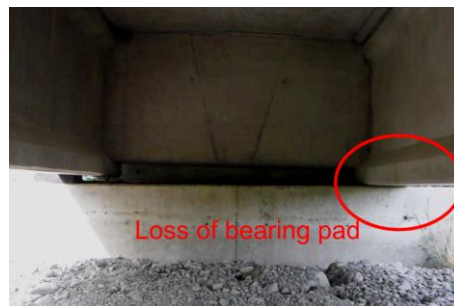
(b) Residual displacement of bearing (left in image), unseating from elastomeric bearing (right in image)

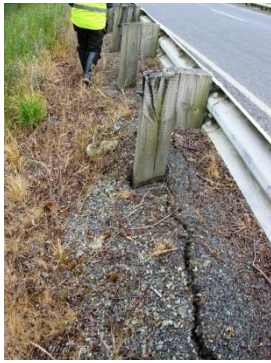
(a) Embankment failure due to lateral spreading (Hanmer River Bridge)

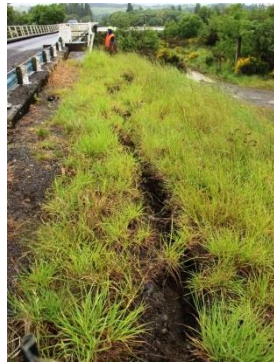
(b) Embankment failure due to lateral spreading (Waiau River Bridge)

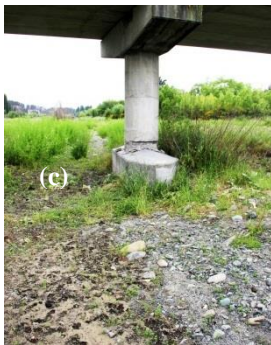
(c) Liquefaction ejecta near central pier. (Mason River Bridge)

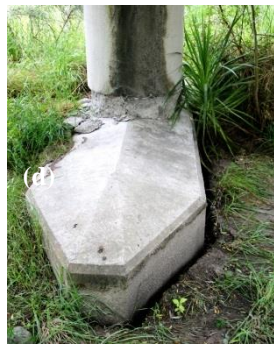
(d) Ground offset with foundation (Mason River Bridge)

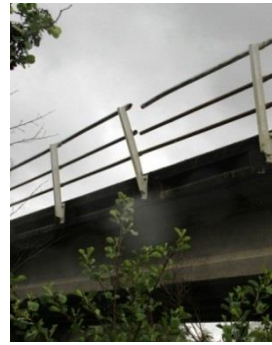
(a) Waiau River Bridge

Guardrail damage was seen at the Waiau, Lower Mason, and Lottery River bridges (Figure 15a-d). At the Waiau River Bridge this was due to deck rotation; at the Lower Mason River Bridge, it was due to approach settlement and compression failure of the movement joint over the central pier; and at Lottery River Bridge, it was due to lateral deck offset and approach settlement (Figure 16a-c). Services were located on Stinking Stream, Waiau Ferry, Hanmer River, Waiau River, Lower Mason River and the Lottery River Bridges. However, damage was only observed at three of these bridges. At the Hanmer River Bridge, the telecom cable was observed to have been stretched and ruptured along with damage to the duct at both ends. The water pipes at the Lower Mason River Bridge had ruptured at the abutments and the central expansion joint, and at the time of the reconnaissance had already been repaired at those sections. The telecom cable duct on the other side of the bridge was observed to have broken at the abutments. At the time of survey, the pipes at the Lottery River Bridge were intact but there was evidence that minor pipe repairs had been carried out at different sections, most likely related to earthquake damage given the amount of residual deck displacement observed.

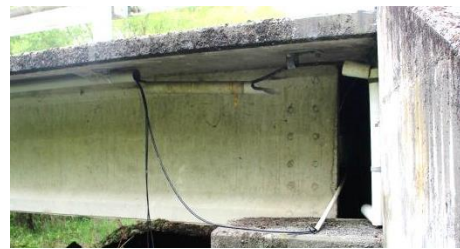
(a) Telecom cable (Hanmer River Bridge)

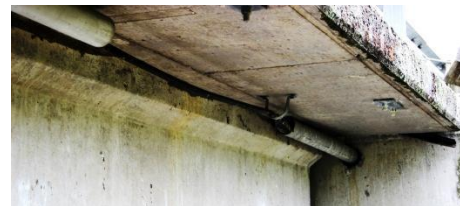
(c) Telecom line (Lower Mason Bridge)

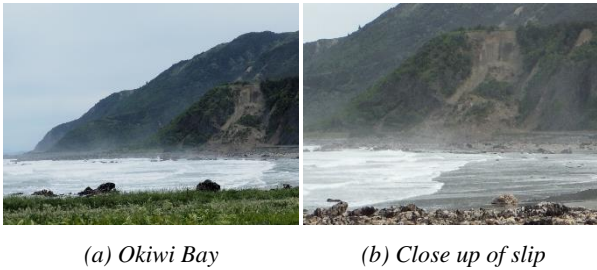
Figure 17: Landslide at the southern end of Okiwi Bay.

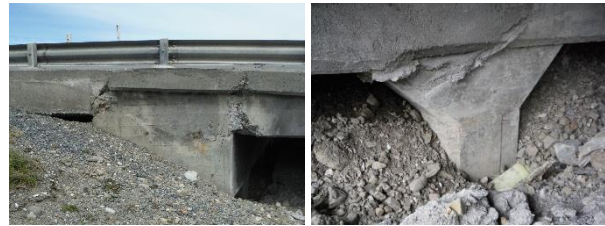
abutments were extensively cracked along with the tops of the abutment columns. Horizontal cracking at the tops of the piers was also observed (Figure 19c).

(a) Abutment cracking (b) Abutment column cracking

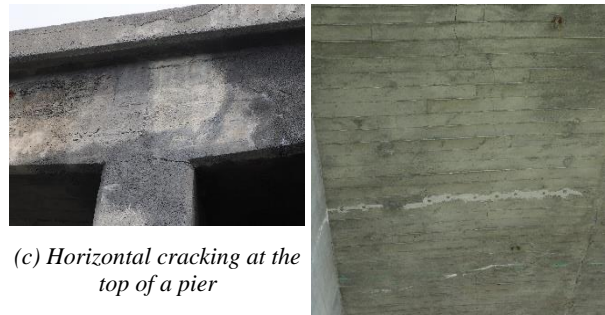
The structural damage observed at the Mororimu Stream Bridge was mainly confined to the substructure, with only one transverse crack found at the underside of the deck on the stream side of the western pier (Figure 19). Both of the

(c) Horizontal cracking at the top of a pier (d) Transverse cracking of the soffit near a pier

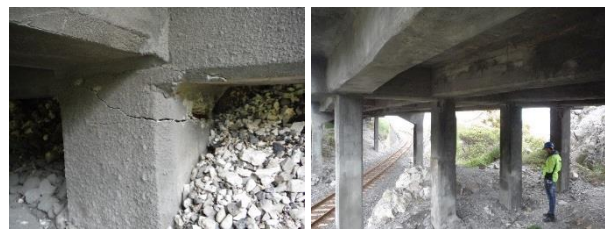
The distribution of damage at the Mororimu Overbridge was different than at the stream bridge, because the pier system was column bents instead of wall piers. Cracking was observed at the tops of the abutment columns as well as the tops of the columns at each of the pier bents (Figure 20). At the central pier (a two column portal frame bent), cracking was extensive around the knee joints of the portal frame bent (Figure 20c). Concrete spalling tended to occur at the tops of the shortest columns at each of the bents resulting in exposed reinforcing (Figure 20d).

(a) Abutment column cracking (b) Spalling at the top of the column bent

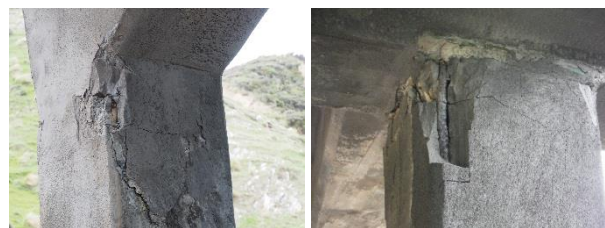
(c) Cracking below knee joint of central pier (d) Close up of exposed bar at the top of a column

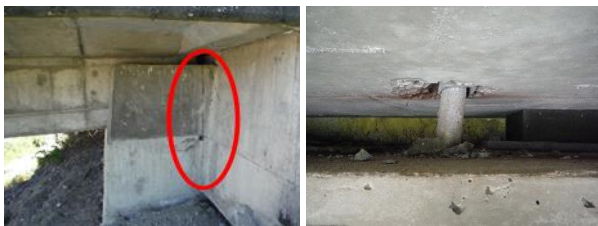
(a) Abutment cracking (b) Hold down rod residual deformation

Most of the damage observed at the Clarence River Bridge occurred at the substructure level. The northern abutment suffered cracking of the west wing wall and vertical cracks at the joint between the back wall and transverse shear key on the east side of the abutment (Figure 22a). The southern abutment was undamaged. Of the 5 piers, only the 2nd pier from the northern end of the bridge was observed to be damaged. Concrete spalling around the pier base was observed (Figure 22d) in addition to a large diagonal crack in pile cap (Figure 22e). Similar cracking damage was reported in the pile caps at a number of the other piers. The diagonal crack in the pile cap implies a vertical punching shear failure had begun to manifest due to the earthquake shaking. At the southern abutment, the vertical hold downs at the tip of the cantilever span had pulled out of the bottom of the box girder causing concrete spalling (Figure 22c). Based on the appearance of a reduced clearance between the abutment seat and the deck soffit the deck appeared to have dropped vertically. At the northern abutment, the vertical hold down rods did not pull through the box girder but were pressed against one side of the surrounding duct (Figure 22b) indicating that the deck had a residual displacement towards the east.

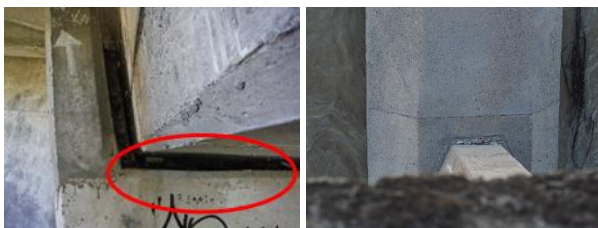
(c) Deck settlement (d) Concrete spalling at pier base

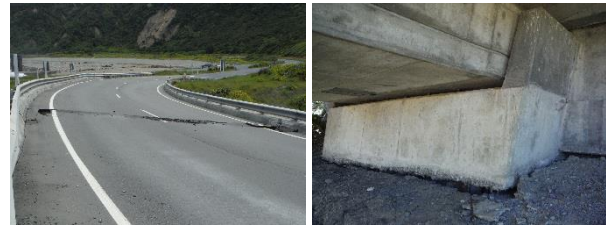
(a) Approach settlement (Mororimu Stream) (b) Abutment fill settlement (Clarence River)

Approach settlement was observed at all bridges examined in this district (Figure 23a). At the Mororimu Stream and Overbridge, the settlement was extreme, being measured to be 100mm. At the Clarence River Bridge, the presence of settlement slabs lessened the direct impact of approach settlement so that there was no abrupt step between the approach level and deck level, however, settlement at the

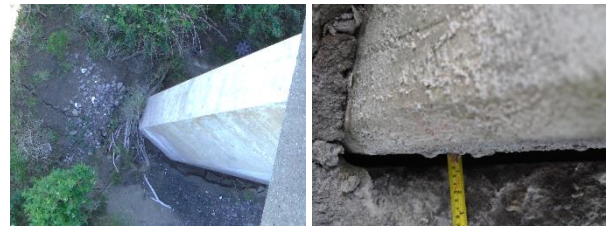
(c) Soil gapping (Clarence River) (d) Soil gapping (Mororimu Overbridge)

northern end of the bridge was large enough to cause a 25mm wide crack in the asphalt where the approach slab meets the abutment. Settlement and slumping of fill below the abutment pile caps and footings (Figure 23b) was observed at all bridges in addition to soil gapping around some of the piers (Figure 23c and d). A severe case of transverse approach spreading was also observed at the southern end of the Clarence River Bridge (Figure 23e). The geotechnical damage does not appear to be due to liquefaction due to the lack of ejecta and lack of fracturing of the ground surface.

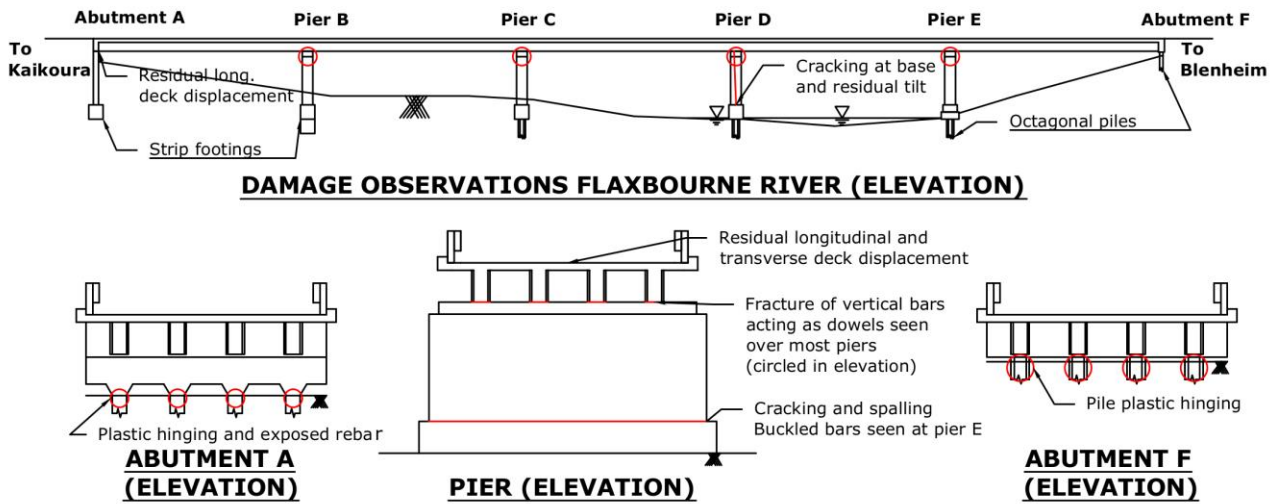
Figure 26: Damage schematics of the Flaxbourne River Bridge.

The Flaxbourne River Bridge suffered damage to both the substructure and superstructure (Figure 26), whereas the Needles Creek Bridge mainly suffered substructure damage. A point of similarity between the Needles Creek and Flaxbourne River bridges in terms of structural damage was the separation of the deck from the piers and abutments due to excessive lateral loading. In the case of the Flaxbourne River Bridge, the vertical dowel bars connecting the deck to the piers and abutment were not sufficient to provide the horizontal shear strength necessary to withstand the lateral seismic demand from the deck. Over the piers, the vertical bars had broken the surrounding cover concrete, bent the confining transverse reinforcement and in some cases fractured (Figure 27a). Over the first pier from the southern end it appeared that all of these vertical bars had fractured. This damage was more severe on the first two piers at the southern end of the bridge. The deck had moved from its original position in a south west direction over these piers (Figure 27b). The two piers closest to the southern abutment appeared to be less damaged than the other two piers where the deck-pier connection was not as badly damaged. At the third pier from the south end of the bridge an angled crack was observed at the top of the pier indicating that the pier-beam connection had started to fail the concrete plinth in shear.

In terms of substructure damage at the Flaxbourne River Bridge, plastic hinging occurred in the foundations at both abutments as well as cracking with reinforcement exposure and buckling at the base of some of the piers. At the southern abutment, plastic hinging occurred at the top of the foundation columns that extend above the strip footing (Figure 27c); and at the other abutment, plastic hinges formed at the top of the piles. Concrete spalling was more significant at the south abutment, fully exposing the longitudinal reinforcement of the abutment columns.

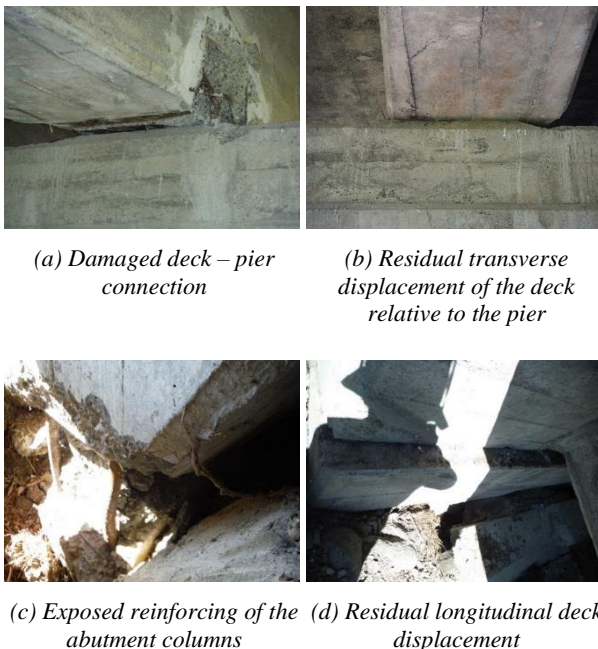
Figure 27: Abutment and superstructure damage at the Flaxbourne River Bridge.

The abutment columns were observed to use plain round bars with widely spaced stirrups. At the same abutment, the transverse capping beam on the columns had moved 200 mm towards the river. Also, there was clear signs of longitudinal movement of the beam diaphragm on top of the abutment seat (Figure 27d). At the north abutment, cracking of the piles

extended across the depth of the pile with spalling occurring on both the front and back faces of the piles.

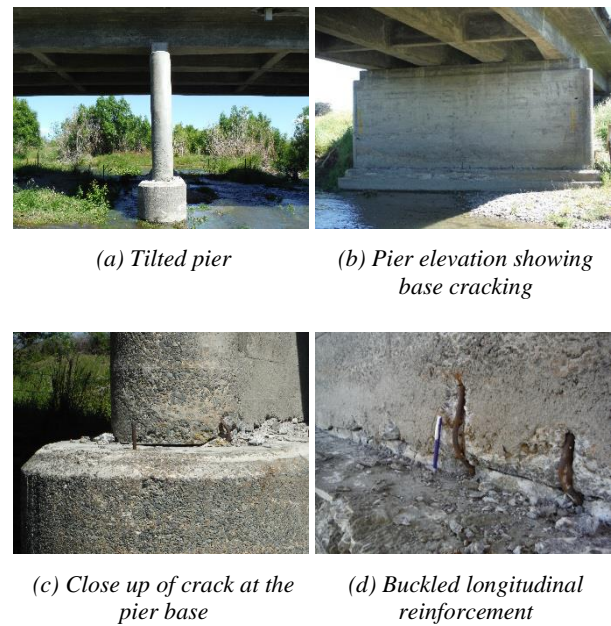
Figure 28: Pier damage at the Flaxbourne River Bridge.

The pier-pile cap interface was only able to be accessed at the three piers closest to the northern end of the bridge and cracking at the pier base was observed at all of these piers. The same piers were observed to be tilted in the longitudinal direction such that the tops of the piers had moved south (Figure 28a). At the base of the piers a single crack was observed to extend through the entire pier-pile cap interface (Figure 28b). Exposure and buckling of longitudinal bars was observed for the two northernmost piers (Figure 28c and d). At the northernmost pier there was evidence that the pier had slid on the crack interface approximately 10mm towards the river channel.

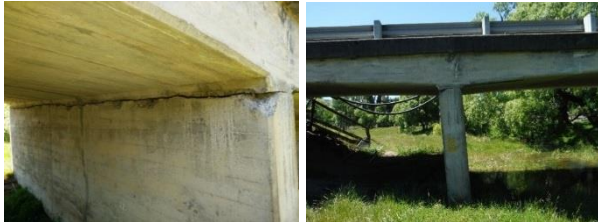
At Needles Creek Bridge, significant plastic hinging at the top and bottom of the piers occurred. However, single cracks instead of distributed cracks tended to form (Figure 29a). The cracks were particularly wide at the two piers at the north end of the bridge. At the pier closest to the north abutment,

exposure and buckling of the longitudinal bars was evident at the top of the pier. This pier also had a residual tilt of about 3° from vertical (Figure 29b). The manner of the tilt was such that the bottom of the pier D appeared to have moved towards the waterway. The mode of cracking of the piers and abutments (over the entire width of the bridge) (Figure 29d) indicates that lateral spreading effects were significant at this bridge [4].

(a) Typical cracking at the top of the piers (b) Tilted pier

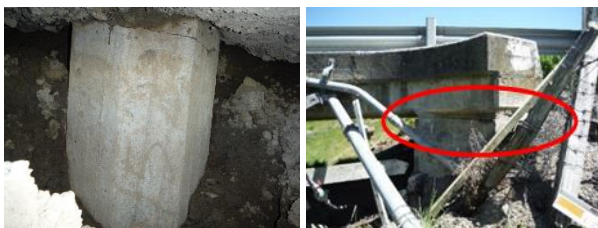
(c) Cracking at the top of the abutment piles (d) Cracking of the abutment-deck connection

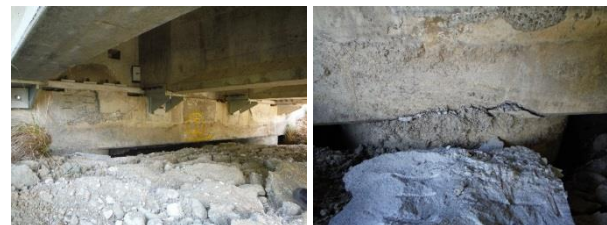
The Waima River Bridge was one of the few bridges visited in the Marlborough district which displayed noticeable residual transverse displacement of the deck. The residual deck displacement had two components, a rigid body translation towards the east and rotation in the transverse west direction between the abutments with the maximum transverse displacement of the deck being near the middle of the bridge. The deck was also twisted about its longitudinal axis with the southbound lane higher than the northbound lane. Cracking and spalling of concrete was observed around the retrofitted steel brackets restraining longitudinal movement of the precast I-beams (Figure 31c). In terms of damage to the substructure, cracking was observed at both abutments in addition to cracking of the top of the abutment piles (Figure 31b). The second (Figure 31d) and third piers from the southern abutment were observed to have noticeable tilting westward. Flexural cracking was observed around the base of the second pier from the southern end of the bridge just above water level at the edge of the waterway, and measured to be approximately 1mm wide. At the time of reconnaissance, only pier damage above ground and water level could be observed and appeared to be minor. However, investigation by Opus International Consultants after the reconnaissance (Figure 33)

(a) View of the south abutment (b) Cracking of the pile – abutment interface

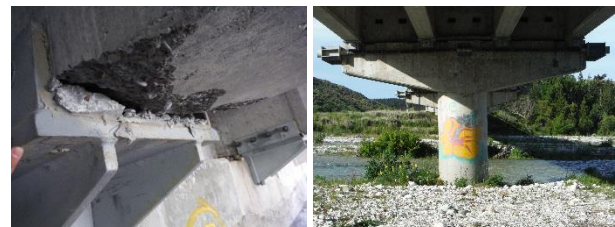
(c) Spalling of concrete around the retrofitted steel brackets attached to the beams (d) Slight tilting of the first pier from the southern abutment westward

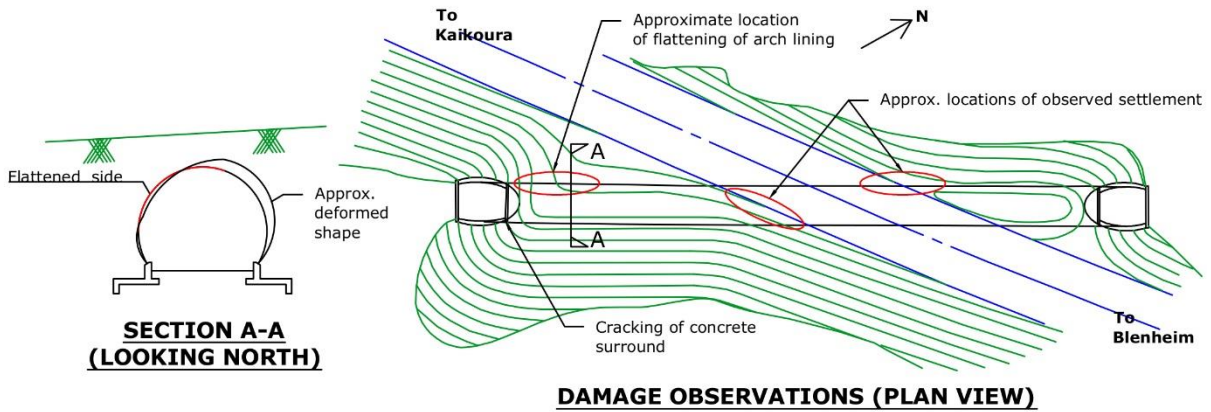
Figure 32: Damage schematics for the Waima Overbridge.

The damage observed at the Waima Overbridge was mainly geotechnical in nature (Figure 32). This is described in the following geotechnical damage section. The main structural damage observed was a flattening of the west side of the arch at the southern end of the structure (Figure 34a) and cracking and spalling of the concrete surround at the southern end of the overbridge (Figure 34d) in proximity of the concrete foundation. The flattening of the arch was large enough to crack the paint protective coating on the corrugated steel section (Figure 34b and 34c).

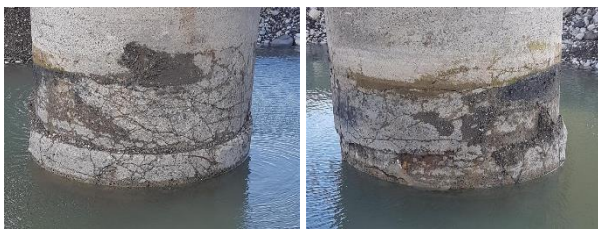
show that pier plastic hinging had occurred below ground level and that only cracking of the concrete occurred within the plastic hinge region.

Figure 33: Typical pier damage observed after excavation and dewatering [courtesy of OPUS International Ltd].

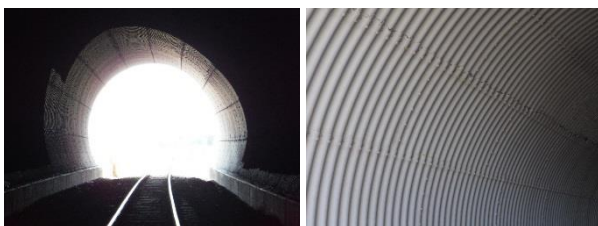
(a) Flattened southern end of overbridge (b) Close up of flattened side of arch lining

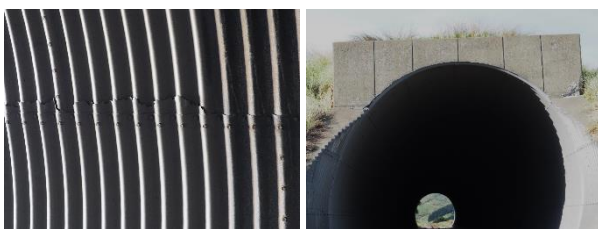
(c) Cracked surface coating at flattened part of the arch lining (d) Cracking of concrete surround at the southern end lining

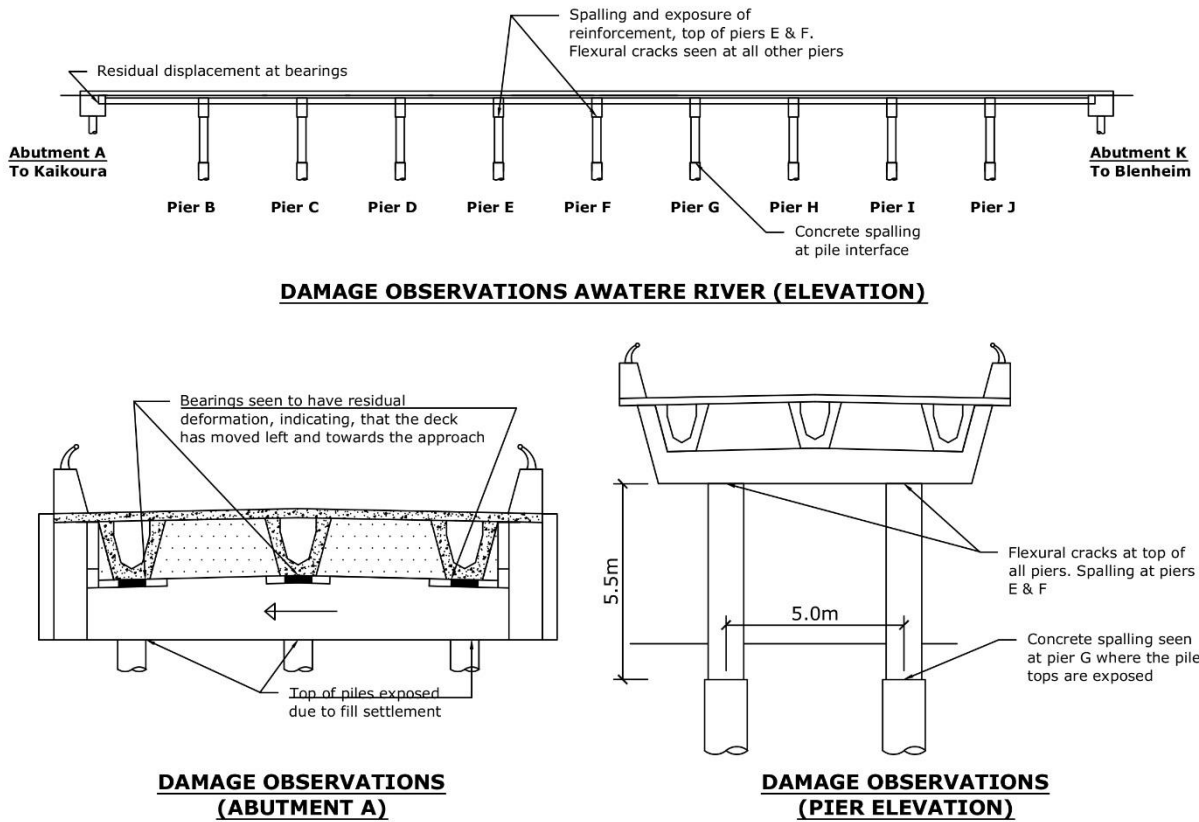
Figure 36: Damage schematics for the Awatere River Bridge.

The Awatere River Bridge sustained flexural cracking at the top of the columns (the pier-pile interface was underground at most piers), at the piers near the abutments, and spalling of concrete at the top and bottom of the columns at the piers close to and at the middle of the bridge (Figures 36 and 37b-d). The bridge deck at the Kaikōura side abutment appeared to have a residual displacement in the southeast direction based on the residual displacement of the elastomeric bearings (Figure 37a). The cracking and spalling in the pier columns mainly occurred at locations where the concrete had been previously repaired with mortar after the 2013 Seddon earthquake (Figure 37d).

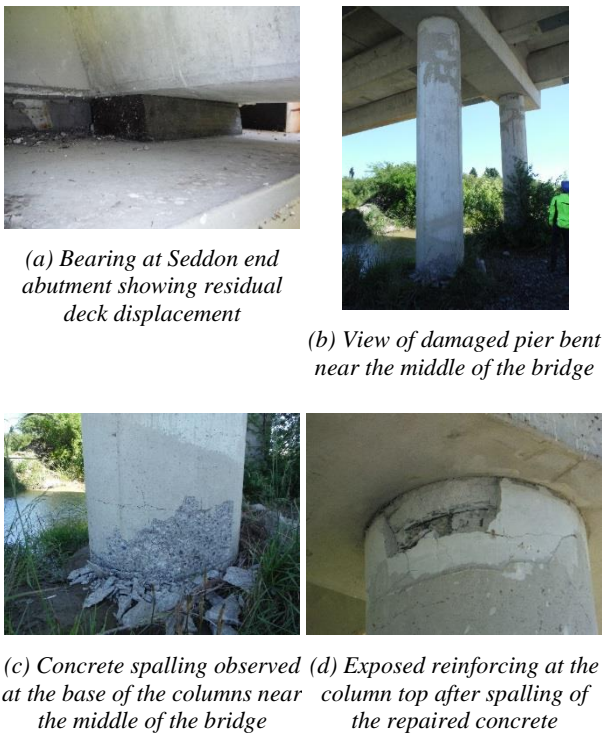
Figure 37: Structural damage at the Awatere River Bridge.

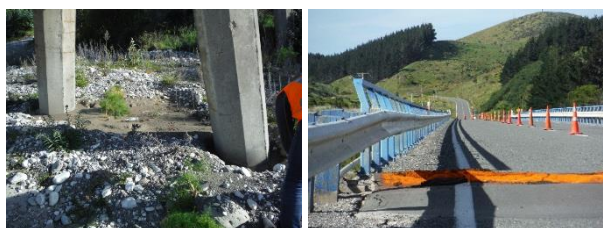
Approach settlement was observed at all of the bridges except the Awatere River Bridge and Waima Overbridge. In the case of the Awatere River Bridge, it is to the author’s knowledge that the abutments are of the Mechanically Stabilised Earth (MSE) wall type and that the lack of settlement is likely to be due to the soil reinforcement preventing spreading of the fill under earthquake shaking. The most severe case of approach settlement occurred at the Waima River Bridge (Figure 38b), 100mm settlement at the southern approach). Settlement of the fill on the abutment slopes beneath the bridges at the Awatere River (Figure 38d), Flaxbourne River, and Needles Creek bridges was also observed. In terms of superficial evidence of liquefaction, an isolated case of ejecta was observed around a few pier-piles of the railroad bridge parallel to the Waima River Bridge (approximately 50m upstream) as shown in Figure 38a. Lateral spreading cracks in the roadway were observed at the Waima River (Figure 38c), whilst, lateral spreading of the creek banks and abutment fill were observed at the Needles Creek bridge. A severe case of soil gapping measuring 100mm was observed at Needles Creek Bridge.

(a) Liquefaction ejecta (b) Large approach settlement
(Orange spray paint)

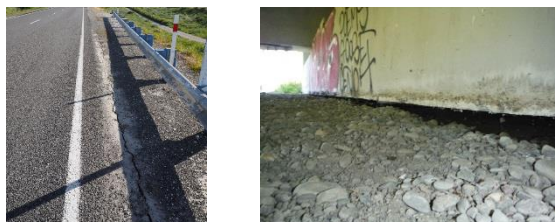
(c) Lateral spread crack at bridge approach (d) Settlement of abutment fill

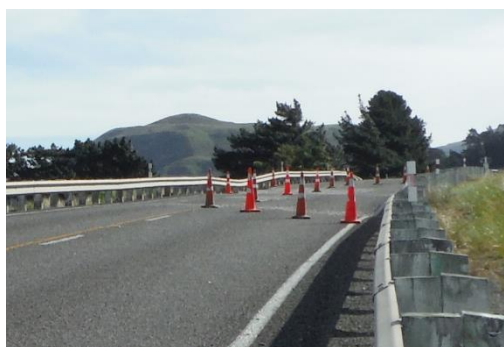
The damage which occurred at the Waima Overbridge was mainly geotechnical in nature. Significant soil settlement of the fill above the arch occurred on the seaward side at the southern end of the structure, resulting in a noticeable dip in the shoulder of the southbound lane (Figure 39). It is believed that the flattening of the tunnel lining on the southwest side was due to settlement of the fill on the southeast side causing unbalanced lateral earth pressure which the flexible lining could not sustain resulting in permanent deformation. More geotechnical details are reported in Stringer et al. [4].

Figure 39: Fill settlement and spread at the Waima Overbridge.
