## **OBSERVATIONS FROM THE EEFIT-TDMRC MISSION TO SULAWESI, INDONESIA TO INVESTIGATE THE 28<sup>TH</sup> SEPTEMBER 2018 CENTRAL SULAWESI EARTHQUAKE**

Richard LAGESSE<sup>1</sup>, Prof. Tiziana ROSSETTO<sup>2</sup>, Prof. Alison RABY<sup>3</sup>, Dr. Andrew BRENNAN<sup>4</sup>, Dr. David ROBINSON<sup>5</sup>, Rohit Kumar ADHIKARI<sup>6</sup>, Muhammad REZKI-HR<sup>7</sup>, Dr. Ella MEILIANDA<sup>8</sup>, Dr. Yunita IDRIS<sup>9</sup>, Ibnu RUSYDY<sup>10</sup>, Intan Dewi KUMALA<sup>11</sup>

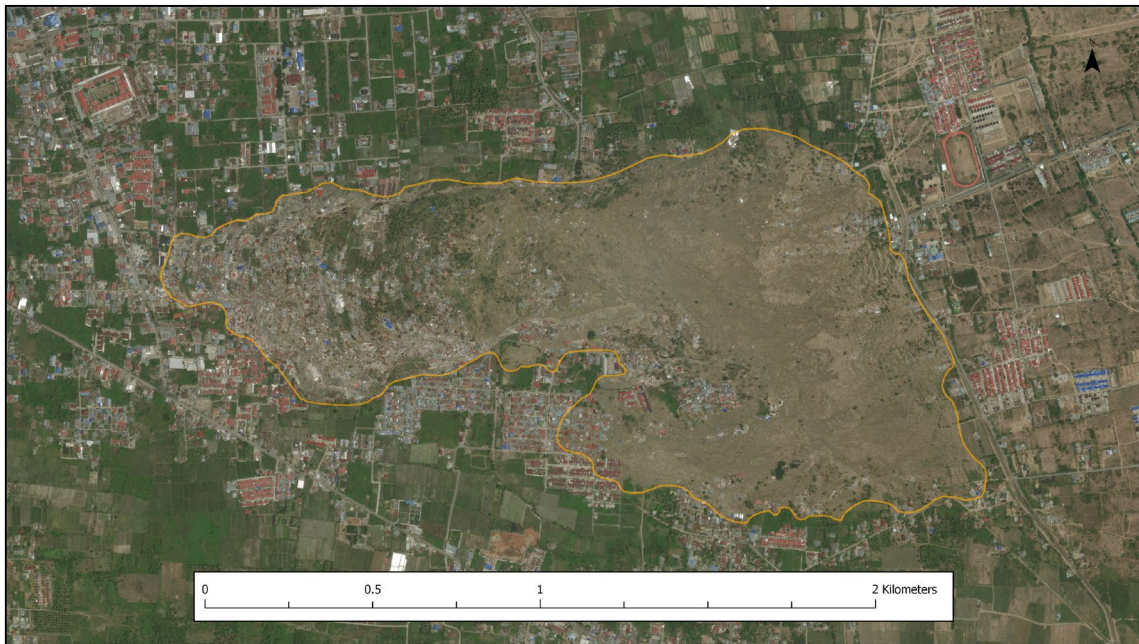
The three main landslides that occurred following the earthquake are considered to be low-angle liquefaction-induced debris flows that were extremely mobile due to significant water content. The causal factors are largely thought to be related to the hydrogeological regimes' interaction with the topography as well as possible anthropogenic factors. Most notably, a man-made irrigation channel running along the eastern side of the valley (Figure 1) appears to be the initiation point of the two largest landslides, including at Petobo (Figure 4), with evidence suggesting the underlying hydrogeological regime is significantly affected by its presence (Figure 5). Whether or not the irrigation channel alone directly led to the failures is cause for discussion, but it is likely at the very least that it contributed to the long runouts due to the significant volume of additional water introduced into the ground.

Figure 4. Satellite imagery showing extent of Petobo landslide area (Imagery: Digital Globe, 2018).

Further investigation is needed to establish a clearer picture of the landslide causes and mechanisms, ideally with some detailed intrusive geotechnical investigation. This will provide information on which to design potential mitigation options, such as drainage infrastructure and modifications to irrigation systems.

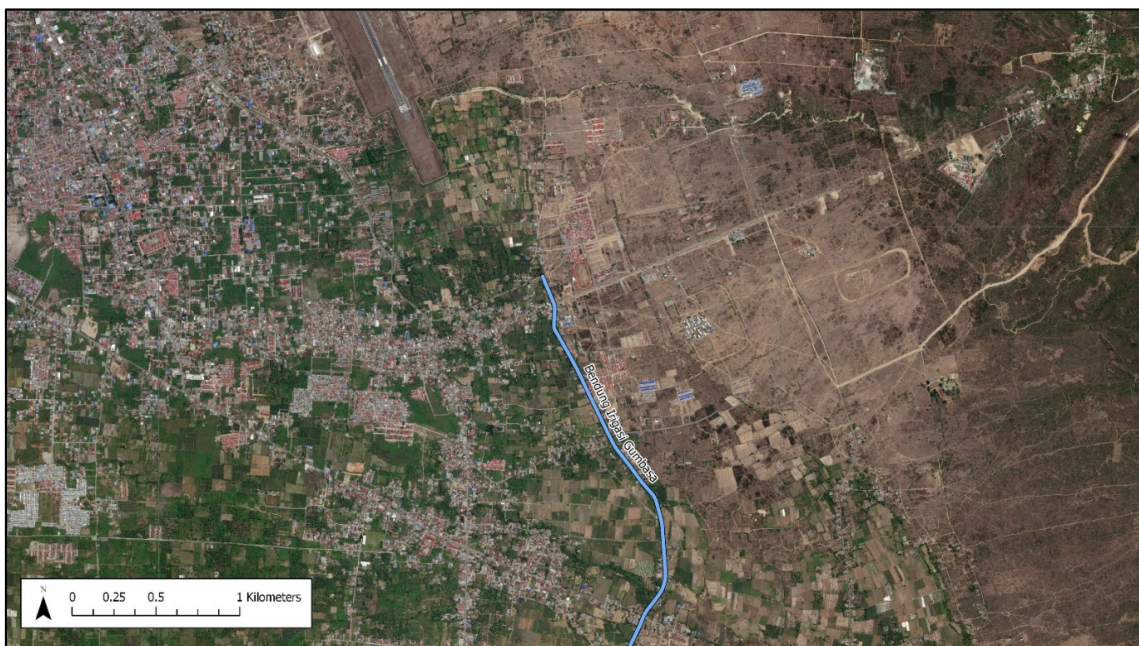
Figure 5. Difference in vegetation growth due to groundwater conditions on either side of the Bendung Irigasi Gumbasa. Green vegetation growth (left) indicates wetter ground conditions as opposed to brown land with lack of vegetation growth (right) indicating mostly dry ground.

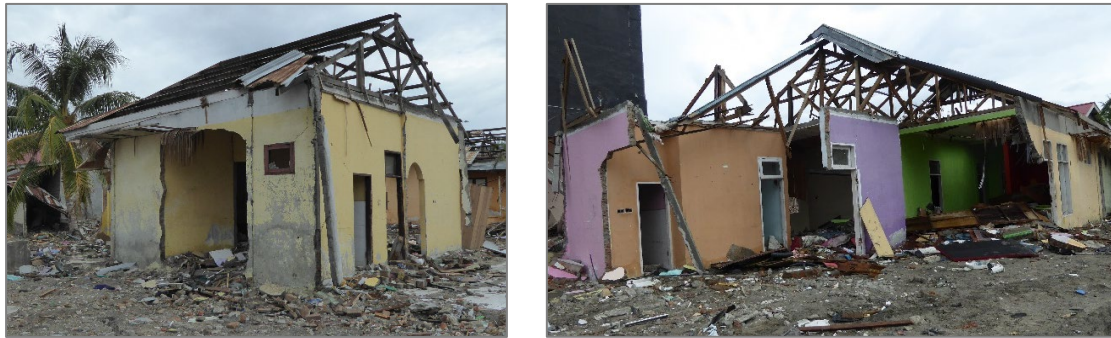
The most common non-engineered construction observed in Palu is confined masonry (CM). Typical damage sustained by CM houses along the coast line in Palu bay area is shown in Figure 10. The main damage pattern is the out of plane failure of walls directly hit by the tsunami waves. In the case of earthquake ground shaking the weak materials used for both the masonry and confining elements resulted in out-of-plane failure of the masonry and cracking and failure of tie-columns.

Figure 10. Heavily damaged CM houses in Palu bay area along the Jl. Rajamoili road, about 100m from coastline. The walls of this house were directly hit by the tsunami inundation.
