3rd International Conference on Urban Sustainability & Resilience
13-14 June 2017, London

Multi-Hazard Vulnerability Assessment of School Infrastructure

The case of Cagayan de Oro - Philippines

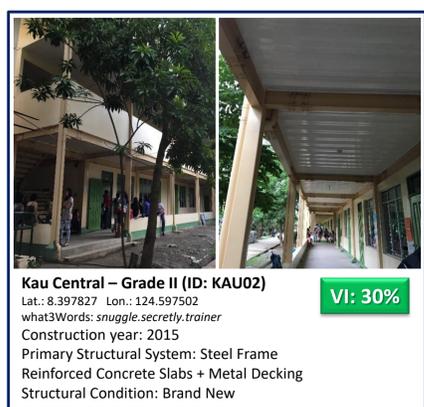
Kau Central – Grade II (ID: KAU02)
Lat.: 8.397827 Lon.: 124.597502
what3Words: snuggle.secretly.trainer
Construction year: 2015
Primary Structural System: Steel Frame
Reinforced Concrete Slabs + Metal Decking
Structural Condition: Brand New
VI: 30%

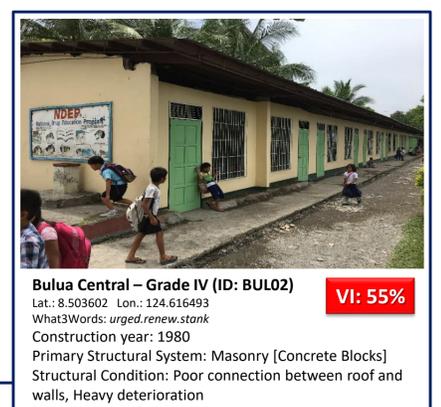
Bulua Central – Grade IV (ID: BUL02)
Lat.: 8.503602 Lon.: 124.616493
What3Words: urged.renew.stank
Construction year: 1980
Primary Structural System: Masonry [Concrete Blocks]
Structural Condition: Poor connection between roof and walls, Heavy deterioration
VI: 55%
