Retrieval analysis of ceramic-coated metal-on-polyethylene total hip replacements

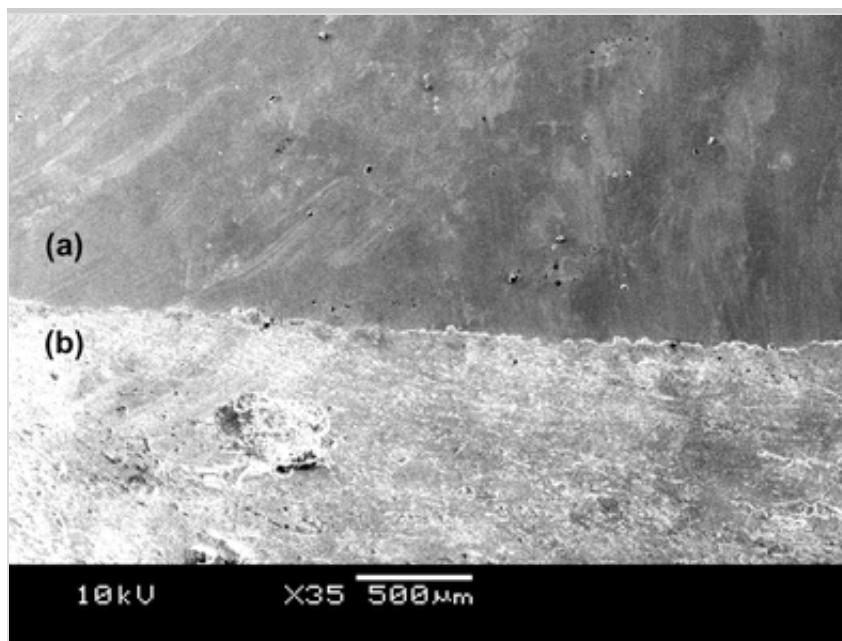
Fig. 2

Examination of the head surfaces under SEM revealed considerable evidence of scratching on the exposed metal surfaces, possibly due to third bodies such as coating fragments (Fig. 2). There were small localised regions of coating loss visible in the coated areas however there was notably less evidence of scratching.

SEM analysis revealed (a) minimal scratching on the coated surface regions and (b) considerable scratching of the exposed surfaces with coating loss

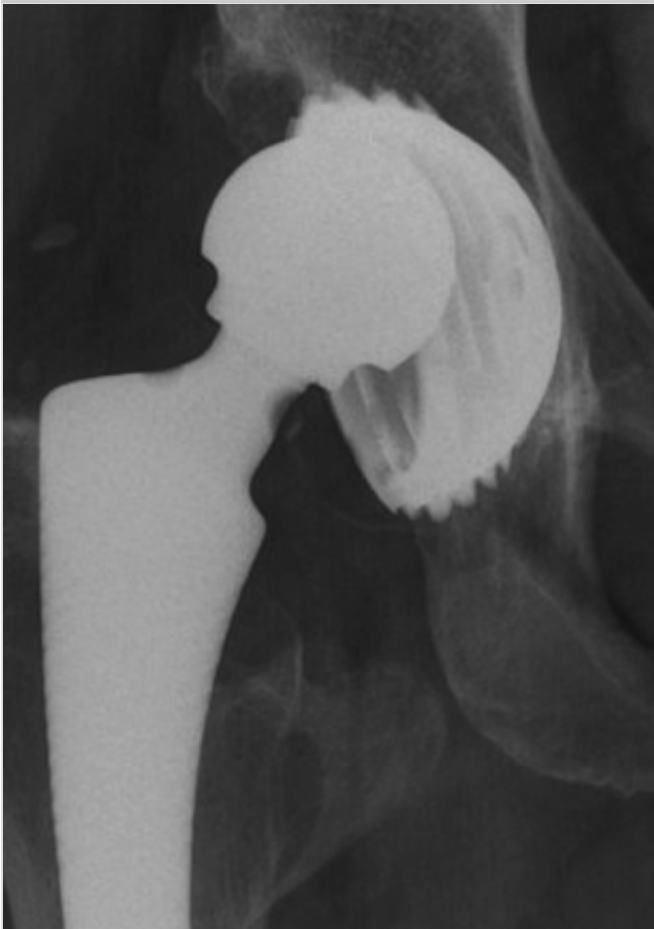
Fig. 3

Of the 35 cases available for radiographic analysis, 37 % (n = 13) revealed evidence of gross polyethylene wear (Fig. 3). All implants that were categorised as demonstrating polyethylene wear upon radiographic analysis

were revised due to a malfunctioning acetabular component, either due to cup loosening or gross cup damage.

Gross polyethylene wear was characterised if the X-ray demonstrated implant head penetration in a supero-lateral direction

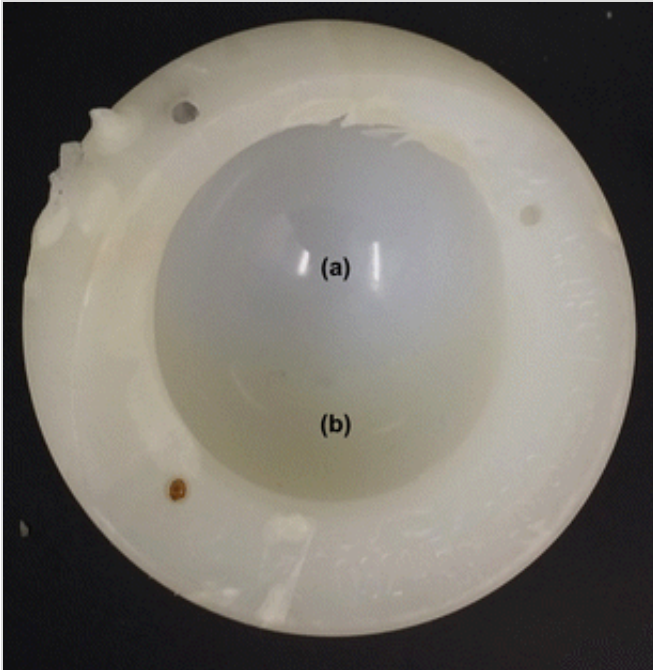
Fig. 4

Upon visual inspection, distinctly dull areas of apparent wear were present on the surface of these components, indicative of abrasive wear (Fig. 4). These regions were adjacent to areas of glossy wear, indicative of adhesive wear.

Inspection of the polyethylene components revealed regions with (a) glossy surfaces and (b) dull appearance to the surface

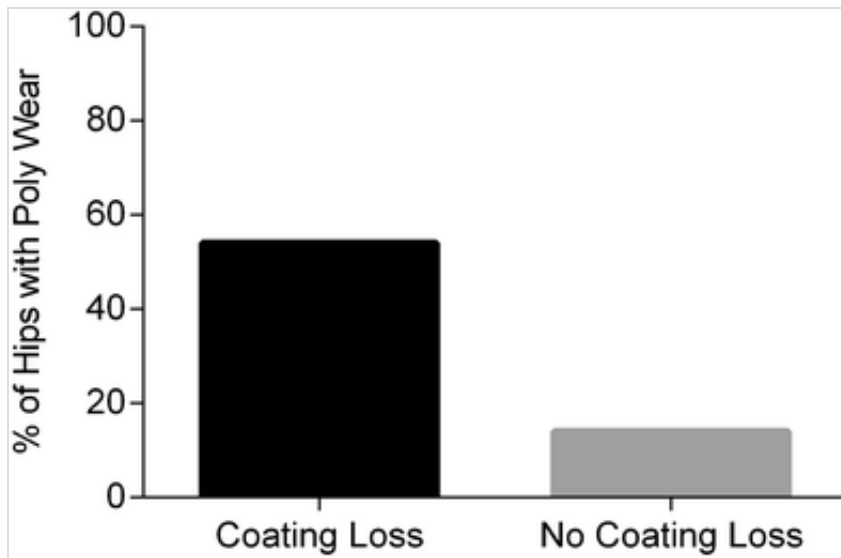
Fig. 5

The incidence of polyethylene wear in samples with coating loss was 54 %, which was significantly ($p = 0.02$) elevated compared to samples with intact coatings (14 %) (Fig. 5).

Plot of the distribution of hips with gross poly wear with femoral heads exhibiting evidence of coating loss or no loss visible
