PROGRESSIVE COLLAPSE: THE CASE OF COMPOSITE STEEL-CONCRETE FRAMES

Riccardo Zandonini¹ riccardo.zandonini@unitn.it, Nadia Baldassino¹ nadia.baldassino@unitn.it,
Fabio Freddi² F.Freddi@warwick.ac.uk, Giacomo Roverso¹ giacomo.roverso@unitn.it

¹Department of Civil, Environmental and Mechanical Engineering, University of Trento
Trento, Italy

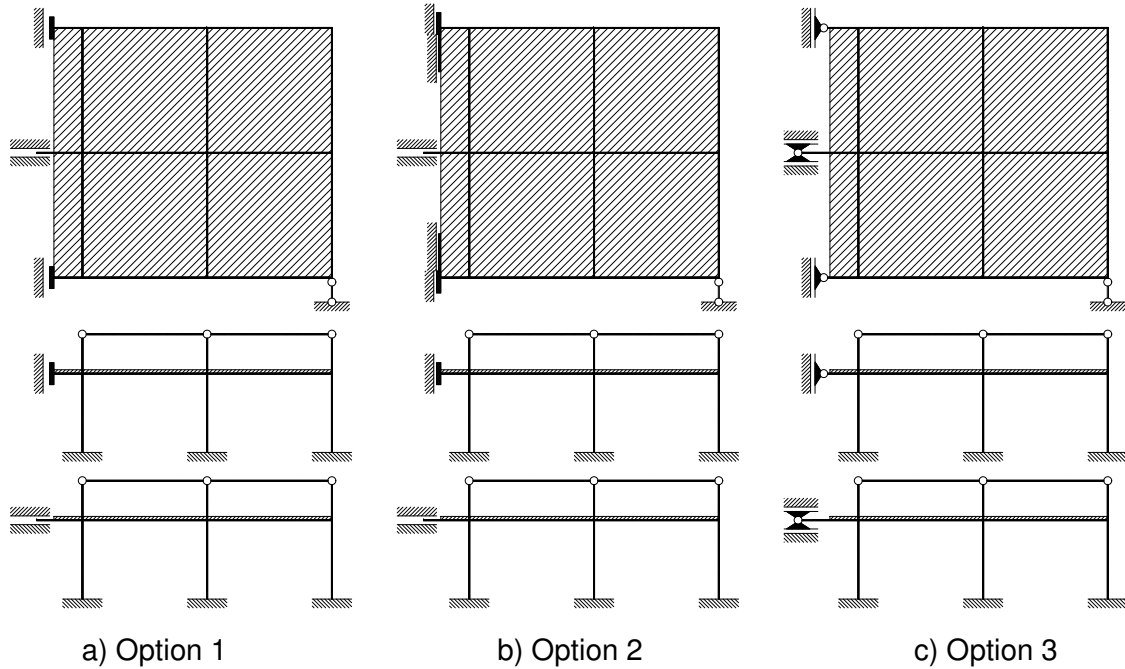
Fig. 5 – Lateral restraints options

the presence of the bracing system and of the remaining part of the reference structure. Furthermore, a system of crowning beams, pinned to the top of the columns, was set up to take into account the influence of the upper stories of the reference structure. As to the sub-frame restraining system, three different options, as illustrated in Figure 5, were considered in the analysis. Comparing the results in terms of deformations and internal forces with the ones obtained from the analysis of the corresponding full-frame, option 3 was selected, where all the lateral restraints are made up by truss elements connected to the steel frame. More details about the design of the lateral restraining system can be found in [14].

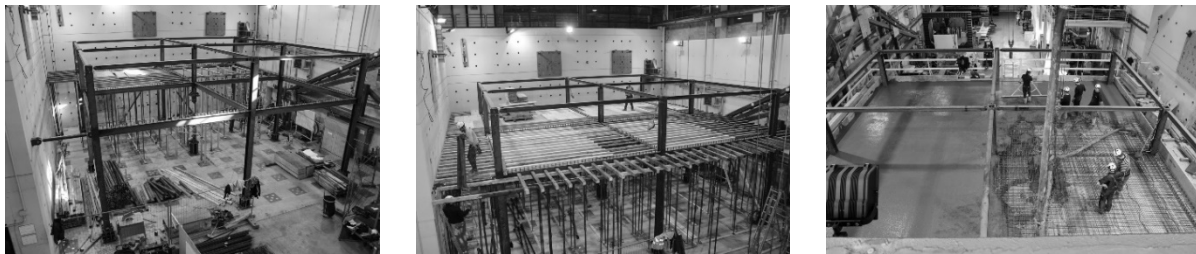
Fig. 6 – The constructional phases

The specimens were built inside the Laboratory of Materials and Structures Testing of the University of Trento. The construction of the frame started with the erection of the steel skeleton and the formwork installation (Figure 6a-b). The reinforcement bars were then positioned and the concrete poured (Figure 6c). Figure 7a-b shows the symmetric specimen completed, while Figure 7c shows the ‘central column’ that was replaced by a hydraulic jack in order to simulate the collapse. During the constructional phases, the central beams were held in position by using a provisional propping system, which was removed when the hydraulic jack was activated.

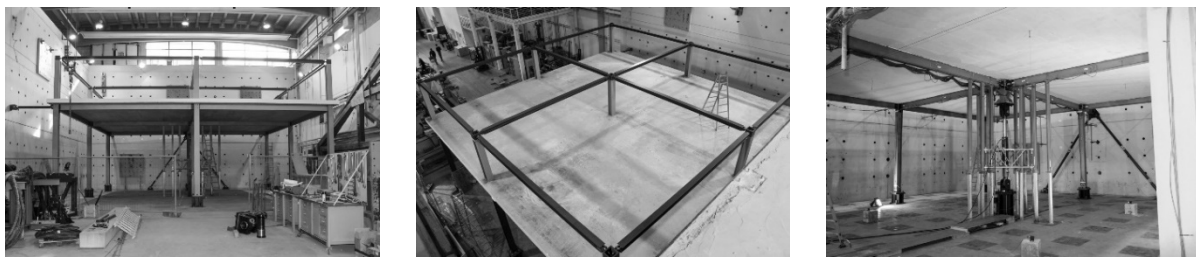
Fig. 7 – The specimen

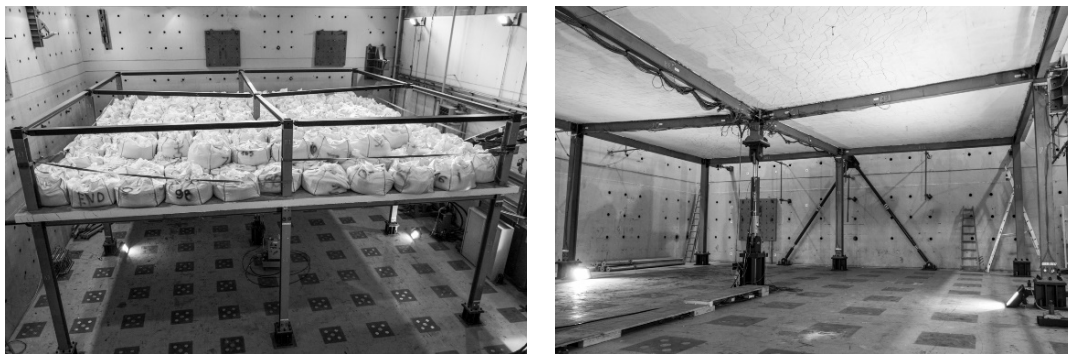
Fig. 11 – The specimen at the end of the test

The cracking pattern on the top side of the concrete slab revealed the formation of 'compressive rings' typical in slabs where the membrane forces are activated.
