# Beagle 2 on Mars – The Discovery Assessed

Dr Jim Clemmet (Beagle 2 Chief Engineer)

With no contact following landing on Christmas Day 2003, the Beagle 2 mission was declared lost February 2004. A glinting object seen in Mars Reconnaissance Orbiter HiRISE camera images has been identified as the Beagle 2 late 2014. This paper presents the evidence that the objects seen are indeed Beagle 2 through a series of evaluations of the objects identified on the surface.

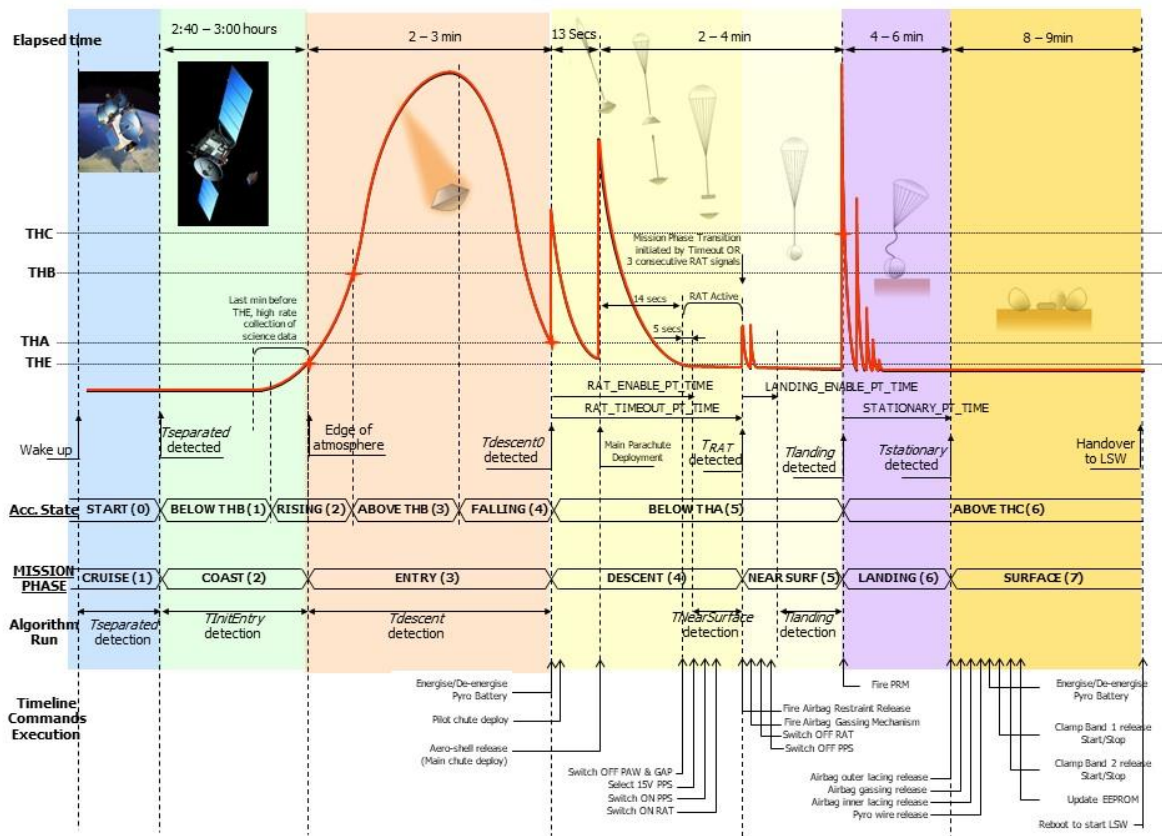
**Figure 3: Entry, Descent and Landing Sequence for Beagle 2**

The Probe entered the thin Martian atmosphere at an altitude of 120km with the correct entry angle, angle of attack and 14rpm spin rate, all set by Mars Express trajectory and orientation at the point of separation and Beagle 2's 3.5kg Spin-up and Ejection Mechanism. The combination of the aerothermal performance, pilot parachute and main parachute was designed to slow the lander down to first impact with the surface of Mars at 16 m/s in a little less than 5 minutes, under the control of the Probe software.

From Top of Atmosphere, the descent trajectory was planned with 3 main phases. The first is defined by the deceleration from 20,000 km/h with aerodynamic heating peaking at a temperature of 1700°C. During this phase the probe was protected by its aeroshell front heatshield and back cover incorporating ablative tiling. Software continuously monitored the output from the 2 accelerometers to sense the deceleration profile and commanded the mortar to fire and deploy the 1.9m pilot chute. The speed decelerated from supersonic to subsonic values, and the aeroshell was then released from the lander, with the small pilot chute pulling back the rear cover. The momentum of the lander pulled out the 10m main chute and full inflation occurred a 2.6 km altitude, 340 km/h. The resulting drag separated the lander from the front shield. At approximately 280 m above the ground travelling at 16m/s, the landing sequence was initiated by the Radar Altimeter Trigger (RAT) sensing the Martian surface, leading to inflation of the airbag assembly, encapsulating the lander. First surface impact occurred minutes after main parachute inflation. The main chute was autonomously released by sensing this 200g shock and would collapse close to this point of impact.

The airbags continued to bounce along the descent trajectory, the distance depending on descent velocity, terrain characteristics, surface wind and airbag pressure. After detecting that Beagle 2 was stationary, the 3 segments comprising the 2m diameter airbag assembly were released simultaneously by the probe software and the lander fell to the surface to survive a 400g impact shock. The distance travelled by each segment depends upon their residual gas pressure and terrain topology and is predicted to be no more than 10m from the lander. Finally the Probe software released the lander clamband and central bolt before handing over to the Lander on-surface operations software.

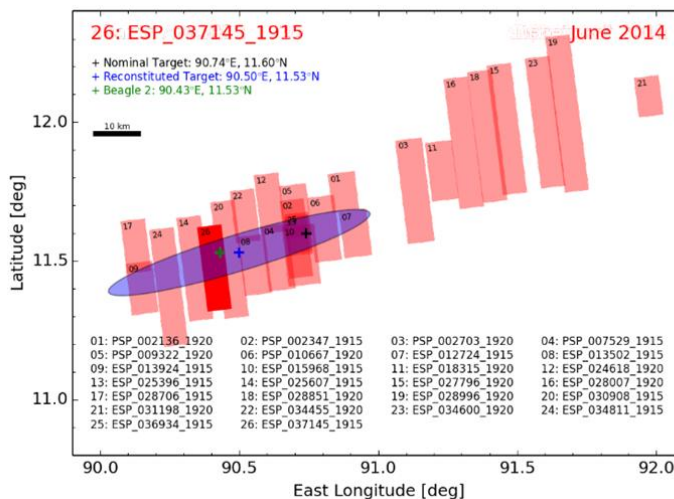
**Figure 5: HiRISE Images: Updated Landing Ellipse & ESP\_030908\_1915**

A number of images across the updated landing ellipse had been acquired over time by the HiRISE camera on NASA's Mars Reconnaissance Orbiter (MRO), (Figure 5). Since the loss of Beagle 2 many individuals had been scanning HiRISE images but without any joy. In 2014 Michael Croon, previously a part of ESA's MEx operating team, recognised that there was a gap in the imaging of the landing ellipse and asked for a new image. Once available, Croon identified an unusual glint and requested an overlapping image. The glint was there again and Beagle 2 had been found (Ref.1). Subsequent evaluation lead to the announcement of the discovery of Beagle 2 on the surface of Mars in January 2015. The Beagle 2 Lander, the rear cover and the main parachute can be seen (Figure 6). With a HiRISE image comprised of a billion pixels, each of about 300mm and a fully deployed lander fitting inside a 1.8m diameter footprint, spotting Beagle2 was a remarkable discovery.

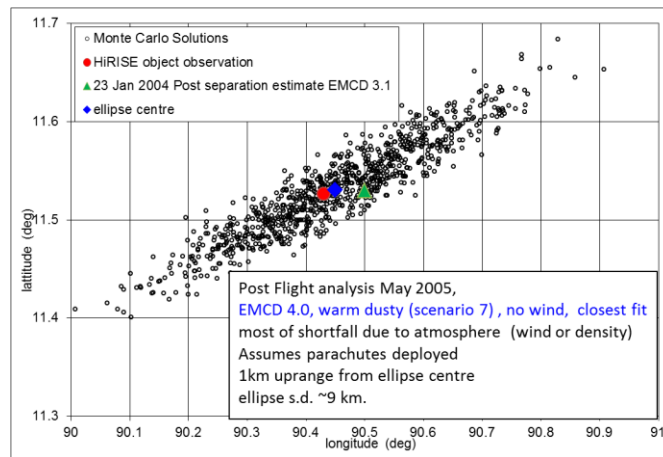
**Figure 13: Location in updated Landing Ellipse (May 2005)**

The entry and descent analysis was rerun using Mars Express flight dynamics data provided following the ejection of Beagle 2. Figure 13 presents the output of this work and shows Beagle 2, located through the HiRISE images, incredibly just 5km from the centre of the revised landing ellipse and 20km from the original target.

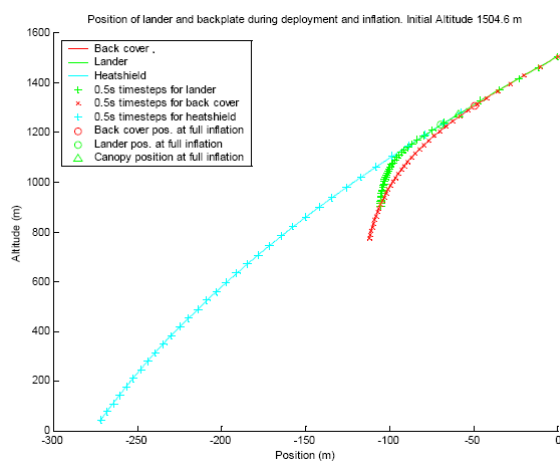
**Figure 14: Dispersion of Hardware on Mars Surface**

Output from the analysis conducted to assess the potential for re-contacts between main parachute and back cover during the descent sequence, Figure 14, also provides an indication of the distribution of the hardware on the Martian surface.

The analysis was only performed in the 2D plane of the landing ellipse major axis and stable behaviour had been assumed. Heatshield tumbling from high altitude, altitude sensitive cross-winds and residual spin during descent under parachutes and asymmetry in airbag bouncing can all result in deviations away from the nominal trajectories but have not been accounted for in these predictions. Some care in interpreting this data is necessary.

Referring to Figure 14(a), the distance between the first impact of the lander (nominal location of the

The back cover would be approximately 30m downstream from the lander first impact/main parachute site. The downstream distance of the back cover is approximately 44m but accompanied by a significant lateral drift under the pilot chute of 90m caused perhaps by high altitude winds. These separations compare well with the simplified predictions.

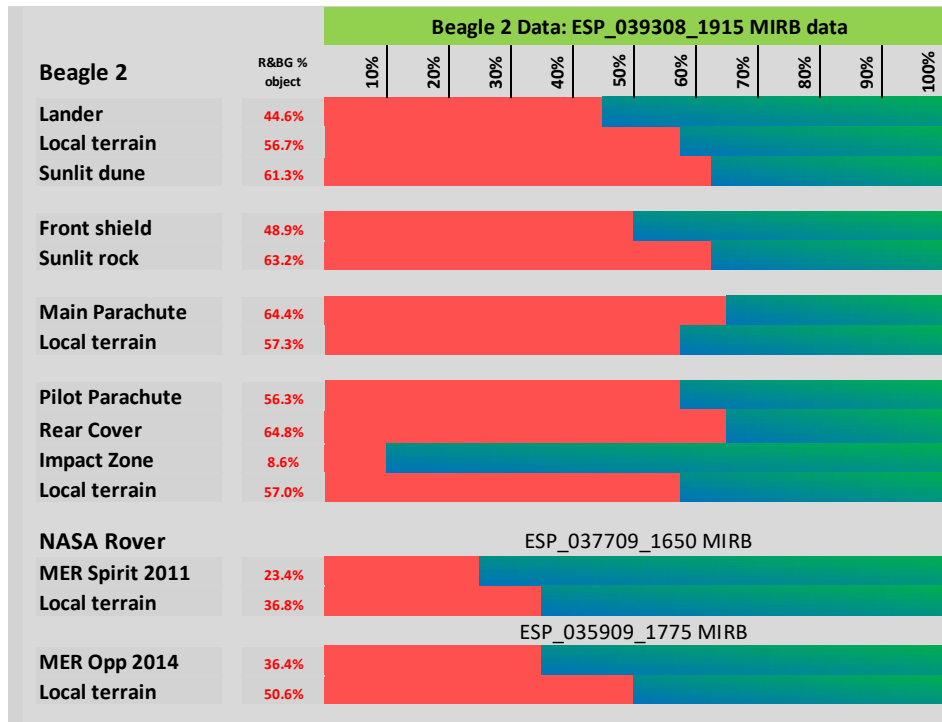
**Figure 15: Comparative Red:BlueGreen Ratios of light reflected from Object Surfaces**

To allow comparison, the analysis has also been repeated for NASA's Spirit and Opportunity Rovers, both having significant solar cell areas. A visual summary of the results from a well illuminated image of Beagle 2 is presented in Figure 15. Differences between the selected objects and the local surface are clear. Comparison of the Beagle 2 highly reflective elements and NASA's Opportunity rover show a similar decreasing Red:BlueGreen ratio characteristic relative to their adjacent terrains. Actual values may differ due to different latitude/longitude locations, atmospheric borne dust and seasonal lighting conditions. This characteristic is consistent with solar cells designed to absorb the red end of the spectrum. In contrast, a sunlit rock shows an increase in the red content.

The main parachute is also distinguishable from sunlit Martian rocks but with a larger relative increase in red content due to its high reflectivity (being white) of ambient light on Mars with its predominant red tinge noting that the parachute will also have accumulated wind borne dust on its smooth fabric surface. The tiled surface of the rear cover appears more alike to the main parachute while the tethered pilot parachute share R:BG ratio with its local terrain. This is not surprising since the HiRISE images show their movement across the terrain resulting in their smooth surfaces being contaminated by the Martian soil and dust. Both are very distinctive from the dark disturbed impact surface, which has a very low red content. The R:BG ratios for natural objects are common within the search region. The R:BG ratios for the more highly reflective and alien Beagle 2 and MER hardware are unique.

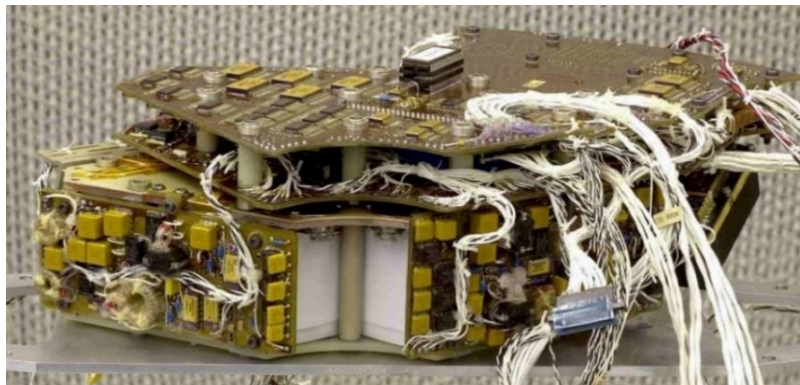
**Figure 25: Electrical Assembly**

*(Incorporating Computer and Power PCBs, Transceiver and Battery)*

The complex assembly of the lander electrical hardware is unconventional as can be seen in Figure 25. Whilst every consideration was given to this extremely compact design, including Paschen breakdown voltages, perhaps some undesired behaviour occurred during early operations or perhaps induced by the prevailing Martian atmospheric conditions.
