Marine aerosol weathering of Mediterranean Calcarene stone: Durability of ethyl silicate, nano $\text{Ca}(\text{OH})_2$, nano SiO_2 , and nanostructured consolidating products

Ainara Zornoza-Indart^{1,2}, Paula Lopez-Arce^{3,4}, Karima Zoghalmi⁵, Nuno Leal⁶ and Joaquim Simão⁶

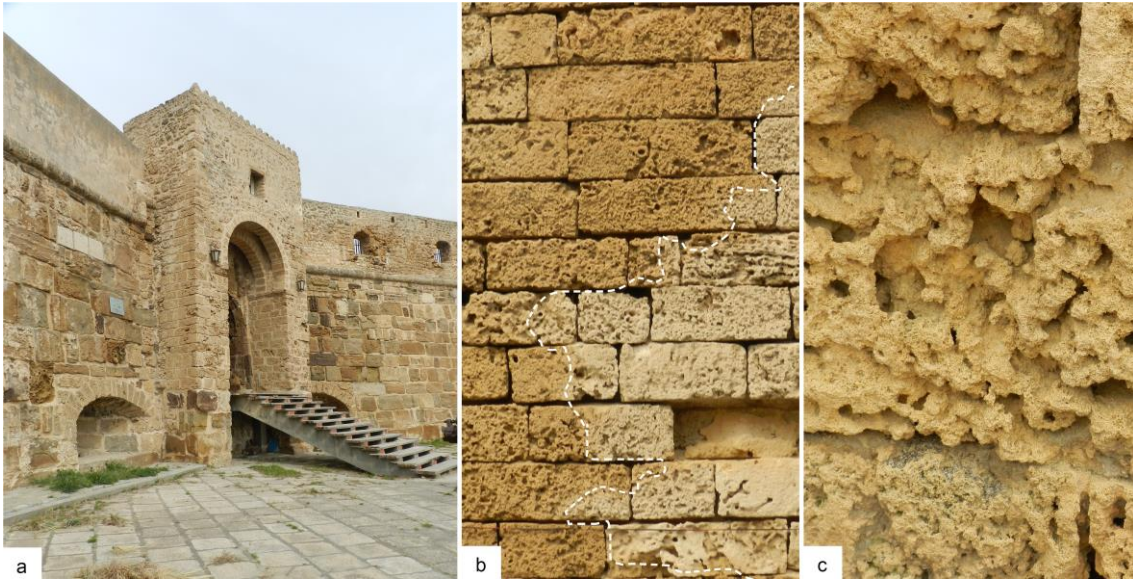
Figure 1. a) Spanish Fort of Bizerta (view from the port); b) Wall of the Fort with honeycomb weathering and moisture problems; c) Honeycomb weathering and loss of material on decayed stone ashlar

Regarding the extrinsic factors, honeycomb weathering can take place under different environments but it is a very common decay pattern of stones exposed to marine aerosol or sea-spray action in coastal areas. The particles of seawater present in the atmosphere mainly originate by the breaking of gas bubbles when the waves collapse (Monahan, 1986). Their principal chemical components are the same as those present in average marine water, being sodium, magnesium, calcium, potassium, and strontium the main cations, and chloride, sulfate, bromide, and bicarbonate the most important anions (Mottershead et al., 2003). Although the term “honeycomb” has been used for a long time (since the nineteenth century), the origin of this type of deterioration pattern is not completely understood, and some controversy still exists about the processes leading to it. Several authors point out the wind erosion, temperature changes, exfoliation, freeze/thaw cycles, salt crystallization, or microorganism action as main causal factors (among others) leading to physico-chemical modifications of the affected stones. However, there is a shortage of laboratory experiments to test many theories proposed for honeycomb development. Relative humidity (RH) and salt crystallization are widely considered as the main factors involved in this weathering progress, concluding that disintegration of mineral grains from the stone surface is the result of physical stress caused by water evaporation and salt crystallization (Mustoe, 1982). Besides RH and soluble salts, some experiments have proved that a heterogeneous wind flux towards the stone surface is a significant agent in this type of pattern development. In fact, Rodriguez-Navarro et al. (1999) refer to wind as one of the key factors in the generation of honeycomb weathering, promoting salt crystallization by evaporation of soluble salts between the mineral grains, causing the formation of small cavities on the stone surface. Reduction of air pressure inside these cavities enhances wind speed, thus accelerating salt water evaporation, promoting a faster and more effective disaggregation in the surrounding regions.

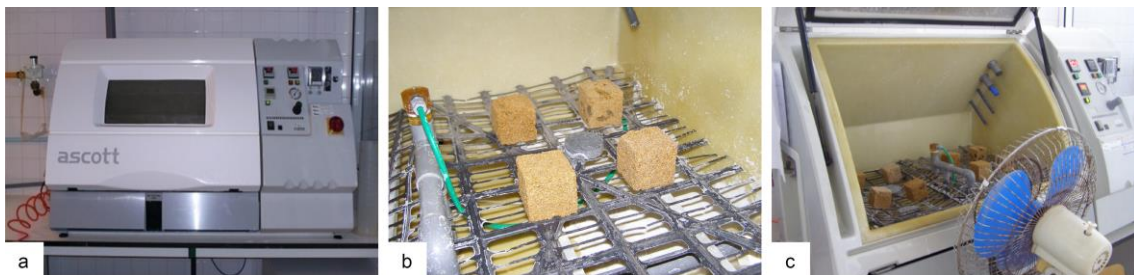
Figure 3. Marine aerosol accelerated ageing test. a) Marine aerosol ageing chamber; b) Drying process without ventilation (6h); c) Drying process with ventilation (6h)

A marine aerosol ageing test was carried out to evaluate the effect of a sea-spray atmosphere while checking the stability of the applied consolidation treatments. It was assessed if the applied products entailed a durability increase of the stone subjected to this type of weathering. The ageing test was carried out with one of the blank specimens (B2-1) and in one sample treated with each consolidating product and environmental conditions (B2-5, B2-7, and B2-9 under dry environment and B2-11, B2-13, B2-17, and B2-15 under humid environment). The ageing was carried out with one specimen per each type of product because the previously treated specimens were used to perform destructive analyses in order to study the consolidation effectiveness of the products after their application (Zornoza-Indart et al., 2016) (Table 1). To include the wind factor in the process of honeycomb weathering, the standard test UNE-EN 14147 (2004) was followed with adaptations introducing, as a modification, the use of fan ventilation in the drying process of the cycles due to the impossibility of placing an air generator inside the chamber. The ageing test was carried out using a marine aerosol ageing chamber (Ascott S120T) of the Faculty of Sciences and Technology of NOVA University of Lisbon (Portugal) (Figure 3a). Samples were submitted to 28 cycles consisting of 12 hours of saline fog exposition with a 1:9 solution of sodium chloride (NaCl) in distilled water (35°C), 6 hours of drying without ventilation (25°C) (Figure 3b), and 6 hours of drying with ventilation (25°C) (Figure 3c). At the end of the cycles the samples were submerged in deionized water to remove the absorbed salts. The volume of water in the tank was three times the total volume of the specimens. This process is very slow and the water was changed every day until desalination was completed. The salt removal was considered completed following the standard, when the conductivity of the solution in contact with the specimens does not exceed twice the characteristic initial value of the water. The conductivity was measured with a HI98311 tester (Hanna Instruments).
