Historical earthquake parameters by geological and seismic site analysis: the 1908 Cerbón earthquake (Spain)

Keywords Historical earthquakes · Slope instabilities · Pseudo-static simulation · Superficial earthquakes · Hydrogeological effects of earthquakes

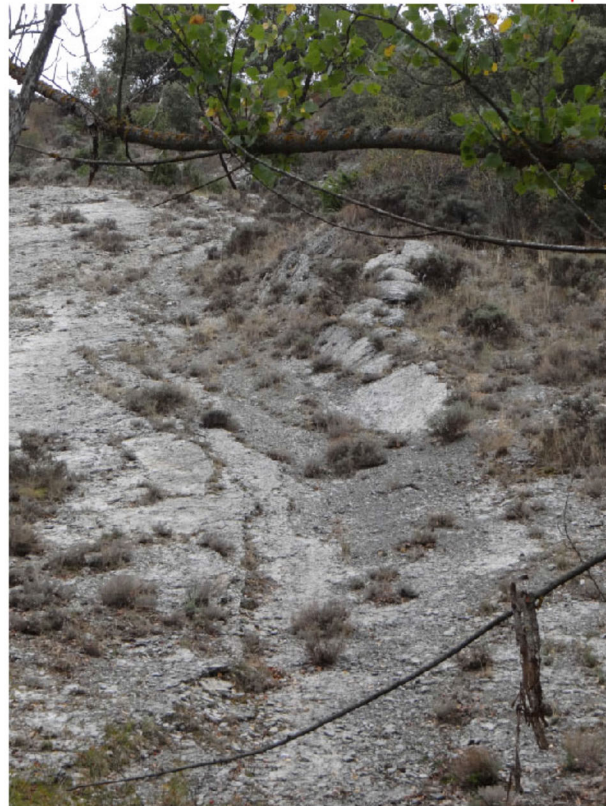
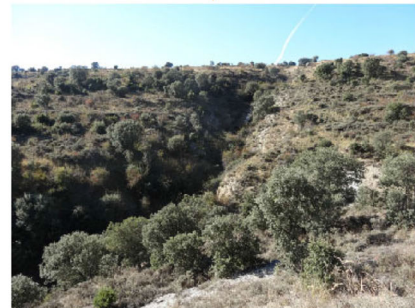
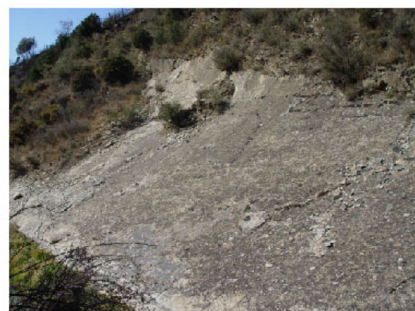
Traction fractures

Pressure ridges

Inclined strata near reverse fault

Fig. 9 Ruptures and folds of rocky landslide induced by the 1908 Cerbon earthquake

slope, except in the E-SE where the relief is elevated as a gentle promontory, on which the ruins of the Majada del Colorado are found. The area resembles a rectangle of some 350 m in the direction of the strata, by around 200 m wide, and it has been delimited by fractures that have individualized the block that was displaced by an earthquake (Fig. 9).

- In the middle of the rectangle (Figs. 7, 9), three pressure ridges are folded and fractured subparallel to each other, where the strata have been uplifted. They are systematically folded with the same orientation ($N30^{\circ}$ E approx.). These ridges are subperpendicular to the open fracture above, and they are crossed by a fracture along the axis of the ridge, as well as by other small fractures perpendicular to the axis (Figs. 7, 9).

- In the western part, three or four fractures have opened up to about 2 m depth, parallel to the above-mentioned ones (Figs. 7, 9). Naranjo (1908) described them as follows: to the SW, and along the minor axis of that ellipse, a large crack appeared, which swallowed the debris to a general depth of around 2 m; it left the walls perfectly vertical, separated by 1–2 m and, at some points, by up to 10 m, with an accompanying crack to the NE. There was another shorter one a short distance away. In the NW, there was another long, rectilinear fissure, divergent from that in the SE, but smaller. Likewise, there is another central fault following the longer middle axis of this ellipse. These fissures are quite easily recognized today.

of the zone as a whole (Fig. 9). Some of the ruptures are open, slightly displacing the terrain as a series of small scarps, which affect the thin soils of the hillsides. Though the ground is tectonically altered, the general tone of the relief has not been modified, but the impression is that a seismic event provoked the rupture that affects the recent soils.
