PERFORMANCE OF ROAD BRIDGES DURING THE 14 NOVEMBER 2016 KAIKŌURA EARTHQUAKE

**Alessandro Palermo¹ Royce Liu^{2,3}, Adnan Rais³,
Brandon McHaffie³, Kaveh Andisheh³, Stefano Pampanin⁴,
Roberto Gentile³, Iolanda Nuzzo³, Mario Granerio³,
Giuseppe Loporcaro³, Chris McGann⁵ and Liam Wotherspoon⁶**

ABSTRACT

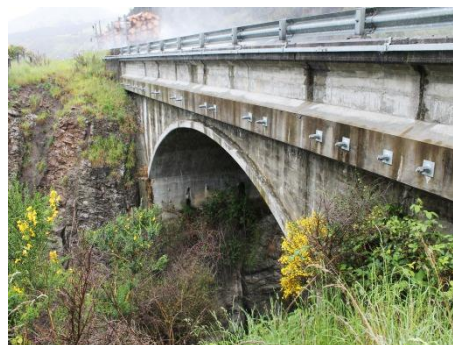
(a) Glenallan Stream Bridge SH7

The three bridges inspected on SH7 are single span bridges, of which the Stinking Stream Bridge and the Brown Stream Bridge have precast deck beams, while the Glenallan Stream Bridge is a cast-in-situ arch bridge. The Stinking Stream Bridge sustained moderate damage due to lateral spreading effects, causing approach settlement, and displacement of the wing walls along with minor cracking; which led to a speed restriction being placed on the bridge. The other two bridges had minor cracking, but were mostly unaffected in terms of operations.

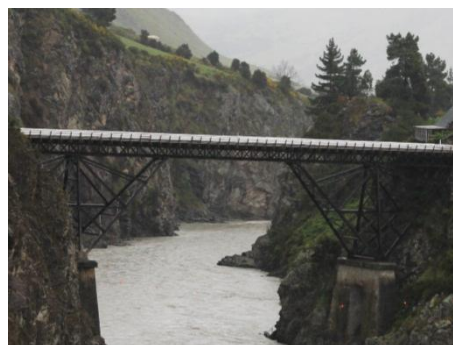
(c) Waiau Ferry Bridge SH7A

The other bridges west of the epicentre were not seriously affected either. The Leslie Hills Road Bridge was unaffected by the earthquake and is a two span steel composite deck bridge. Of particular note with this bridge is that the span over the river channel has an obvious sag which could lead one to believe that the deck buckled due to lateral spreading. However, it is the authors understanding that the distortion of the deck existed prior to the earthquake due to a pier being lost in a flood. Similarly, the Waiau Ferry Bridge on SH7A, a single span steel truss bridge, was unaffected by the earthquake. However, the Hanmer River Bridge located further north on SH7A, a multi-span bridge with precast concrete beams supported on wall piers, did suffer damage at the wingwalls due to lateral spreading along with minor approach settlement. Damage caused by pounding at the abutments was observed along with some displacement at the seals, joints and bearings, due to transverse ground shaking. Nevertheless this bridge was open without any restrictions. Figure 7 shows a selection of photos of the bridges west of the epicentre.

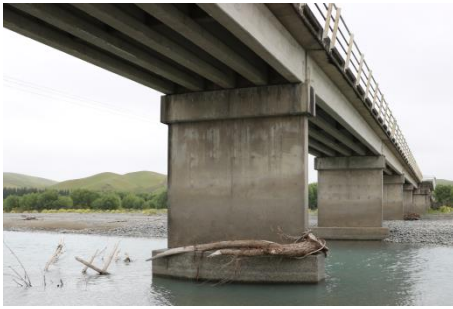
(a) Oblique View

The single-lane Waiau River Bridge (Figure 8) was built in 1965. The bridge is a thirty three span, simply supported, precast beam bridge with five, 17m, I - Beam units making up the superstructure. The superstructure is supported by seat abutments and thirty two wall piers typically 4m wide but 7.25m wide at each of the two passing bays. The beams and diaphragms between them sit on 12mm thick full-width neoprene strip bearings at each of the supports, and is restrained by dowels holding the end diaphragms of the deck at the piers and abutments.

Damage sustained by the Waiau River Bridge was moderate, with the bridge being operated under speed restrictions. The second and third spans of the bridge on the west side was observed to have been rotated in plan view (Figure 8c). This was clearly visible from the closed expansion gaps at pier 3

From the preliminary performance observations, the Waiau River Bridge structure seems to be quite a rigid structure in the transverse direction, due to the wall pier stiffness. Strong ground shaking was experienced; however this did not damage the structure significantly apart from the deck gap openings at the passing bay transitions and bar buckling at the base of the piers due to the lack of transverse tie reinforcement. The liquefaction ejecta observed at the site in the mid and the eastern end of the bridge was relatively minor, but apparently did not affect the structure. The deck rotation observed was mainly due to the transverse rotation of pier 3 possibly caused by combined effect of settlement and ground shaking. The damage at the approaches and abutments was more significant due to soil subsidence and lateral spreading effects that caused large cracks in the soil embankments. The observations indicated a good overall structural performance of the bridge.

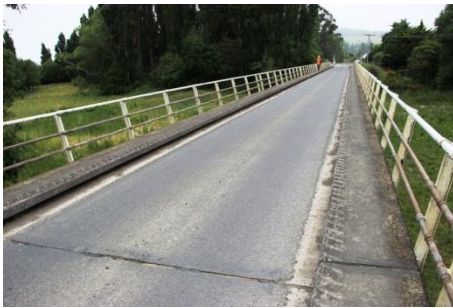
(b) View from top of deck

(upstream side), which showed slight signs of transverse rotation towards the upstream side. However, there was no sign of localized pounding damage despite the residual deck displacements. Also, the abutments showed signs of rotation along with some soil subsidence; pile exposure was observed at the eastern end and extreme abutment cracking at the west end of the bridge (Figure 8d) Most piers showed cracks at the pier-pile cap interface with some minor spalling, while at some piers near the waterway, longitudinal bar exposure and buckling was observed as well (Figure 8e)

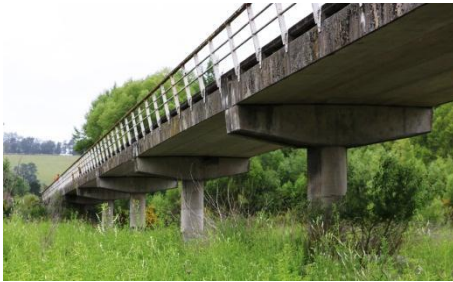
(a) Mason River Bridge – River Road

The Mason River Bridge (Figure 9a) is split in two with a central movement joint similar to the Lower Mason and Lottery River bridges. There are transverse shear keys at the abutments and "tight" internal longitudinal shear keys and linkage bars over all of the piers except the central pier. At the central pier, provision is made for longitudinal movement with loose linkage bars but steel plate lateral support stubs cast into the piers restrain the transverse movement. Therefore, the overall transverse response can be thought of as the deck having a curved displaced shape where the largest transverse

Similar damage observations were made for the Mason River Bridge, where the deck joints had opened or closed, and pier plastic hinges with bar buckling and concrete spalling were observed with increasing degree of damage towards the centre pier (Figure 10c). The pier damage pattern was interesting at this bridge as concrete spalling and rebar exposure occurred mainly on the south side of the piers (transverse loading direction) and tended to be more in the longitudinal loading direction close to the abutments.

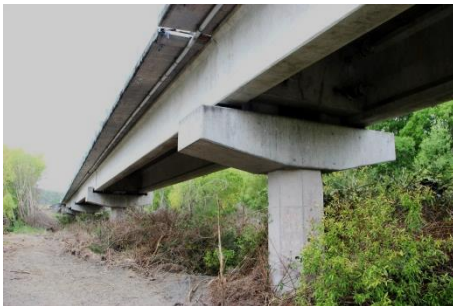
(b) Lower Mason River Bridge - Inland Road

The Lower Mason (Figure 9b) and Lottery River (Figure 9c) bridges are identical in the way they resist lateral loading. These structures have been seismically split in two: longitudinal interaction between each half of the bridge has been isolated by a movement joint with knock off detail, whilst, transverse interaction has been isolated by the omission of transverse shear keys at the central pier. In addition to this, these bridges use a rudimentary form of seismic isolation under transverse loading, whereby there is a large gap between the deck beams and the transverse shear keys such that they may displace an appreciable amount on the supporting elastomeric bearings before contacting the shear keys. This design approach therefore makes use of the low lateral stiffness of the bearings to elongate the period of the structure. There are no transverse shear keys at the abutments. In the longitudinal direction, lateral loads are directly transferred to each of the piers through bearing of the deck diaphragms on concrete upstands working as shear keys. Also, the deck beams are tied together longitudinally by tight linkages and a continuous deck between spans, except, over the central pier. There are no longitudinal linkages at the abutments but the beams rest on wide seats. Therefore, all piers resist longitudinal lateral loading, except the central pier which is effectively much more flexible having no shear keys. Transverse load is transferred to all piers through the bearings but under large displacement response, when the beams contact shear keys, the central pier has lower stiffness than the other piers and will carry lower loads than the others. Until the beams contact the shear keys the overall transverse response can be thought of as rigid body translation of each half of the superstructure.

The Lower Mason and Lottery River bridges suffered similar damage. Observed damage common to both bridges included: damage to the knock-off block at the central pier movement joint (Figure 13a); failure of the abutment knock-off blocks; residual displacement of most of the elastomeric bearing pads at the piers and abutments; and residual displacements at the central pier and abutment movement joints. Unseating of the deck beams only occurred at the Lower Mason River Bridge (Figure 13b), where, at each abutment one deck beam (on opposite sides) was observed to be unseated off the supporting elastomeric bearing. The piers suffered extensive damage at both bridges, where all piers except the central one formed fully developed plastic hinges at the base. Extensive cover spalling, and a significant number of buckled and fractured longitudinal bars were seen at the Lower Mason River Bridge (Figure 10a and 11). Pier damage at the Lottery River Bridge was similar but there was no evidence of bar fracture (Figure 10b).

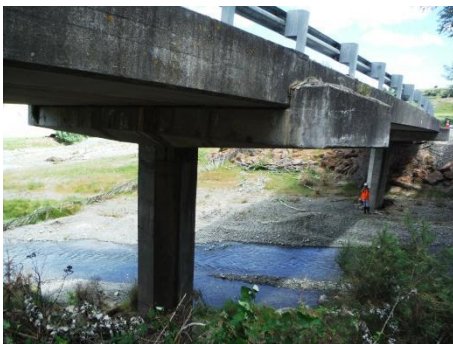
(d) Wandle River Bridge – Inland Road

The Wandle River Bridge (Figure 9d) is curved in plan and has a slope in the longitudinal direction. Linkages, shear keys and elastomeric bearings restrain the transverse and longitudinal movement over the piers, but only linkage bars resist both the transverse and longitudinal movement at the abutments. Longitudinal movement towards the backfill at the abutments is resisted by the abutment back-wall which is cast against the beams with a 6mm separation gap.

Extensive damage was observed to the Wandle River Bridge (Figure 12) which included: separation between the hollow core deck units at the south end of the bridge; translation of deck units in the downstream direction; hinging and rotating of piers towards the upstream side (in the direction of increasing radius of curvature); opening of the deck joints at the abutments, along with significant approach damage (Figure 10d and 10e).

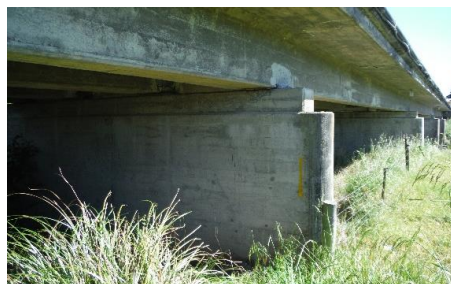
(a) Flaxbourne River SH1

The Flaxbourne River (Figure 25a) and Needles Creek (Figure 25b) Bridges were built in the 1950's and are both 5 span structures supported on wall piers. In the case of the Needles Creek Bridge, the structure is entirely integral unlike the Flaxbourne River Bridge where the superstructure is simply supported on the piers and is only connected to the piers by eight vertical, 32mm diameter dowel bars (two per beam).

The Flaxbourne River Bridge suffered damage to both the substructure and superstructure (Figure 26), whereas the Needles Creek Bridge mainly suffered substructure damage. A point of similarity between the Needles Creek and Flaxbourne River bridges in terms of structural damage was the separation of the deck from the piers and abutments due to excessive lateral loading. In the case of the Flaxbourne River Bridge, the vertical dowel bars connecting the deck to the piers and abutment were not sufficient to provide the horizontal shear strength necessary to withstand the lateral seismic demand from the deck. Over the piers, the vertical bars had broken the surrounding cover concrete, bent the confining transverse reinforcement and in some cases fractured (Figure 27a). Over the first pier from the southern end it appeared that all of these vertical bars had fractured. This damage was more severe on the first two piers at the southern end of the bridge. The deck had moved from its original position in a south west direction over these piers (Figure 27b). The two piers closest to the southern abutment appeared to be less damaged than the other two piers where the deck-pier connection was not as badly damaged. At the third pier from the south end of the bridge an angled crack was observed at the top of the pier indicating that the pier-beam connection had started to fail the concrete plinth in shear.

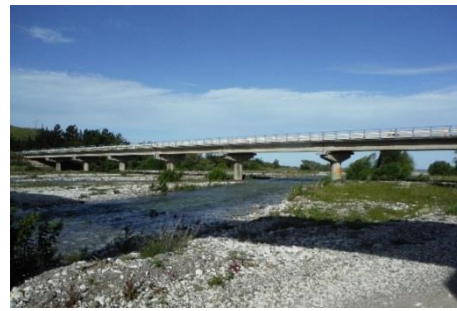
(a) Waima River (Ure) Bridge SH1

The Waima River Bridge was one of the few bridges visited in the Marlborough district which displayed noticeable residual transverse displacement of the deck. The residual deck displacement had two components, a rigid body translation towards the east and rotation in the transverse west direction between the abutments with the maximum transverse displacement of the deck being near the middle of the bridge. The deck was also twisted about its longitudinal axis with the southbound lane higher than the northbound lane. Cracking and spalling of concrete was observed around the retrofitted steel brackets restraining longitudinal movement of the precast I-beams (Figure 31c). In terms of damage to the substructure, cracking was observed at both abutments in addition to cracking of the top of the abutment piles (Figure 31b). The second (Figure 31d) and third piers from the southern abutment were observed to have noticeable tilting westward. Flexural cracking was observed around the base of the second pier from the southern end of the bridge just above water level at the edge of the waterway, and measured to be approximately 1mm wide. At the time of reconnaissance, only pier damage above ground and water level could be observed and appeared to be minor. However, investigation by Opus International Consultants after the reconnaissance (Figure 33)

show that pier plastic hinging had occurred below ground level and that only cracking of the concrete occurred within the plastic hinge region.
