## **OBSERVATIONS FROM THE EEFIT-TDMRC MISSION TO SULAWESI, INDONESIA TO INVESTIGATE THE 28<sup>TH</sup> SEPTEMBER 2018 CENTRAL SULAWESI EARTHQUAKE**

Richard LAGESSE<sup>1</sup>, Prof. Tiziana ROSSETTO<sup>2</sup>, Prof. Alison RABY<sup>3</sup>, Dr. Andrew BRENNAN<sup>4</sup>, Dr. David ROBINSON<sup>5</sup>, Rohit Kumar ADHIKARI<sup>6</sup>, Muhammad REZKI-HR<sup>7</sup>, Dr. Ella MEILIANDA<sup>8</sup>, Dr. Yunita IDRIS<sup>9</sup>, Ibnu RUSYDY<sup>10</sup>, Intan Dewi KUMALA<sup>11</sup>

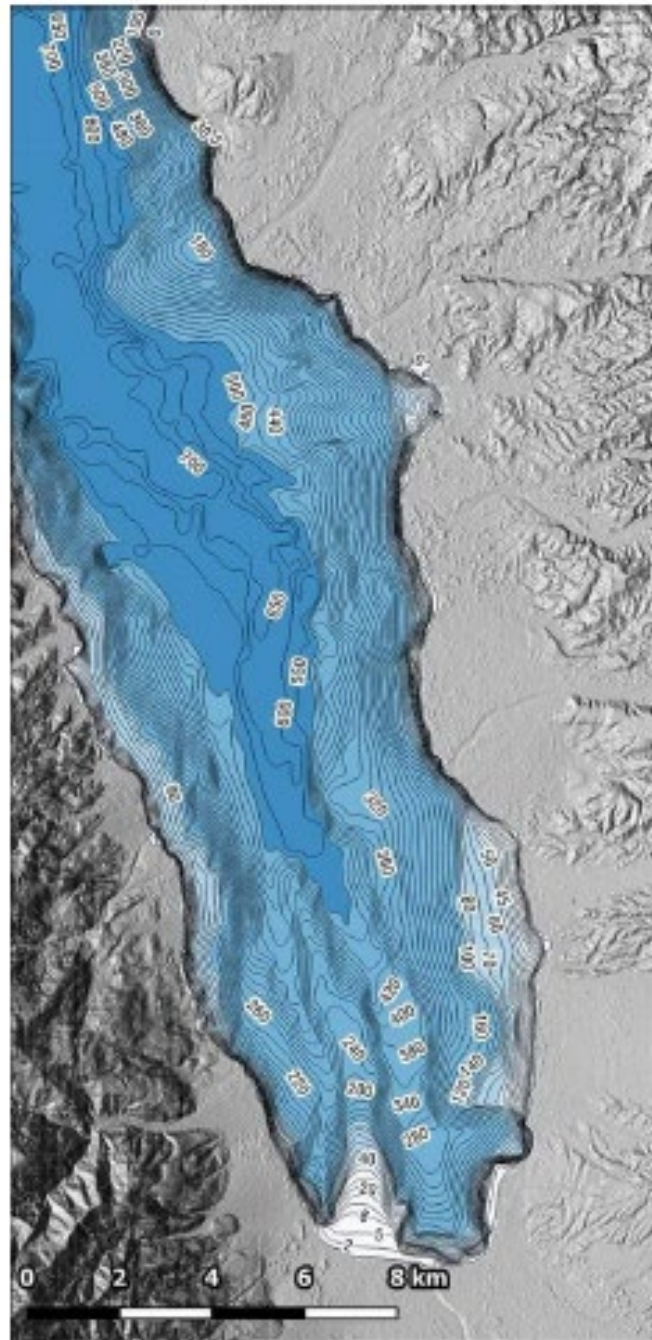
As mentioned above, the 28<sup>th</sup> September 2018 earthquake had a predominantly strike-slip mechanism. The relative movements of the plates in this type of earthquake are largely horizontal, and hence would not typically cause a tsunami, though due to the steep bathymetry of the bay (Figure 8) it is not inconceivable that horizontal movement could displace water (STEER, 2019). Measurements from outside of the bay suggest that a tsunami originating from a location close to the epicentre would not have had time to reach the bay before the first waves were observed (Muhari *et al.*, 2018). There are a variety of causal mechanisms now suggested, amongst which are landslides triggered by the earthquake. This seems plausible given the number of observed sub-aerial landslides that occurred and some slides on the west of the bay that were seen to cause tsunamis (STEER, 2019). However, to date the location of a single submarine landslide of the size required to cause a tsunami of the size recorded has not been identified.

Figure 8. Badan Informasi Geospasial Contour map of Palu Bay before the earthquake, Retrieved from <https://cloud.big.go.id>. Accessed 30 Oct 2018.
