3rd International Conference on Urban Sustainability & Resilience
13-14 June 2017, London

Multi-Hazard Vulnerability Assessment of School Infrastructure

The case of Cagayan de Oro - Philippines

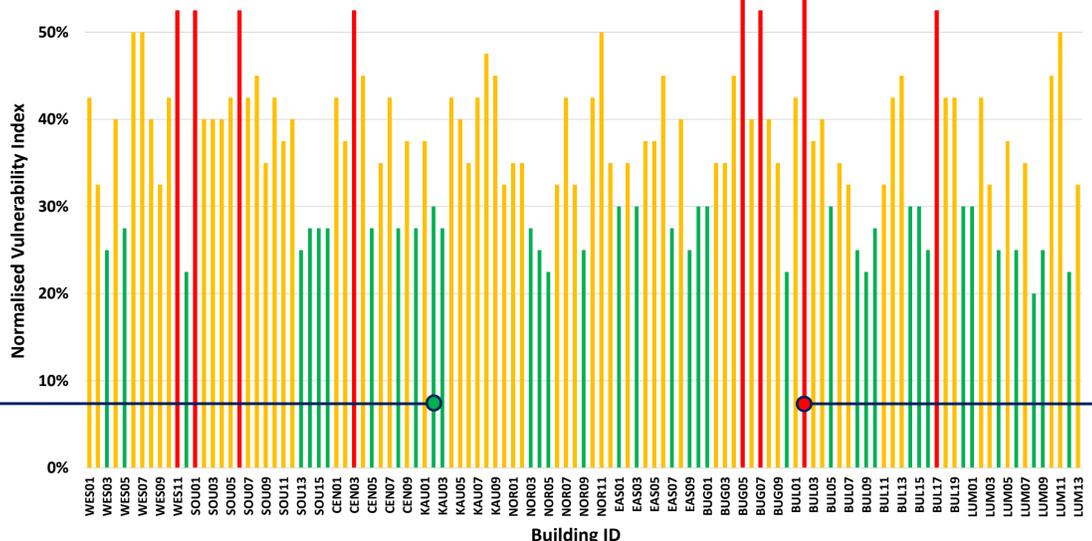
Bulua Central – Grade IV (ID: BUL02)
Lat.: 8.503602 Lon.: 124.616493
What3Words: urged.renew.stank
Construction year: 1980
Primary Structural System: Masonry [Concrete Blocks]
Structural Condition: Poor connection between roof and walls, Heavy deterioration
VI: 55%

Figure 3 - Vulnerability Index (VI) of 115 Surveyed Elementary Schools in Cagayan de Oro – Philippines. A number of cases are illustrated along with some geolocation and structural details.
