Defect imaging in composite structures

Paul Fromme, Marco Endrizzi, and Alessandro Olivo

Citation: [AIP Conference Proceedings](#) **1949**, 130004 (2018); doi: 10.1063/1.5031599

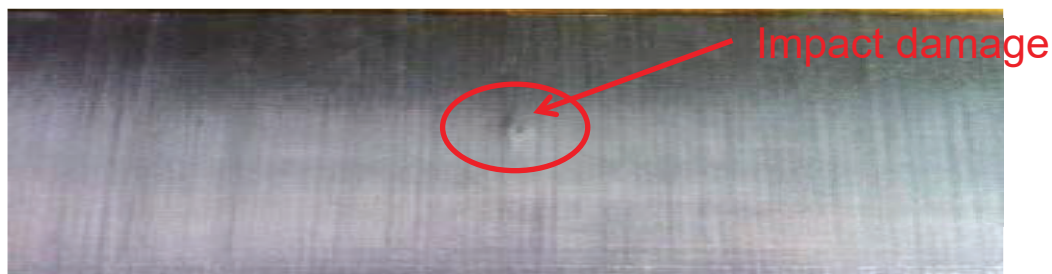
FIGURE 1. Photograph of composite specimen with barely visible impact damage marked.

The specimen had been manufactured and previously investigated by the Composite Systems Innovation Centre, University of Sheffield [1]. The composite component (size: 990 mm x 110 mm) was fabricated with unidirectional pre-pregs using autoclave cure of Cytac 977-2/ Tenax HTS cross-ply laminates. The plate consists of 8 pre-preg layers with a symmetric layup sequence of $[0/90]_{2s}$, giving a thickness of 2 mm. Using standard drop weight impact procedures, the specimen was subjected to a 7.4 J impact damage using a hemispherical 15 mm impactor head. A small degree of fiber fracture and indentation on the surface of the plate can be seen marked in Fig. 1.

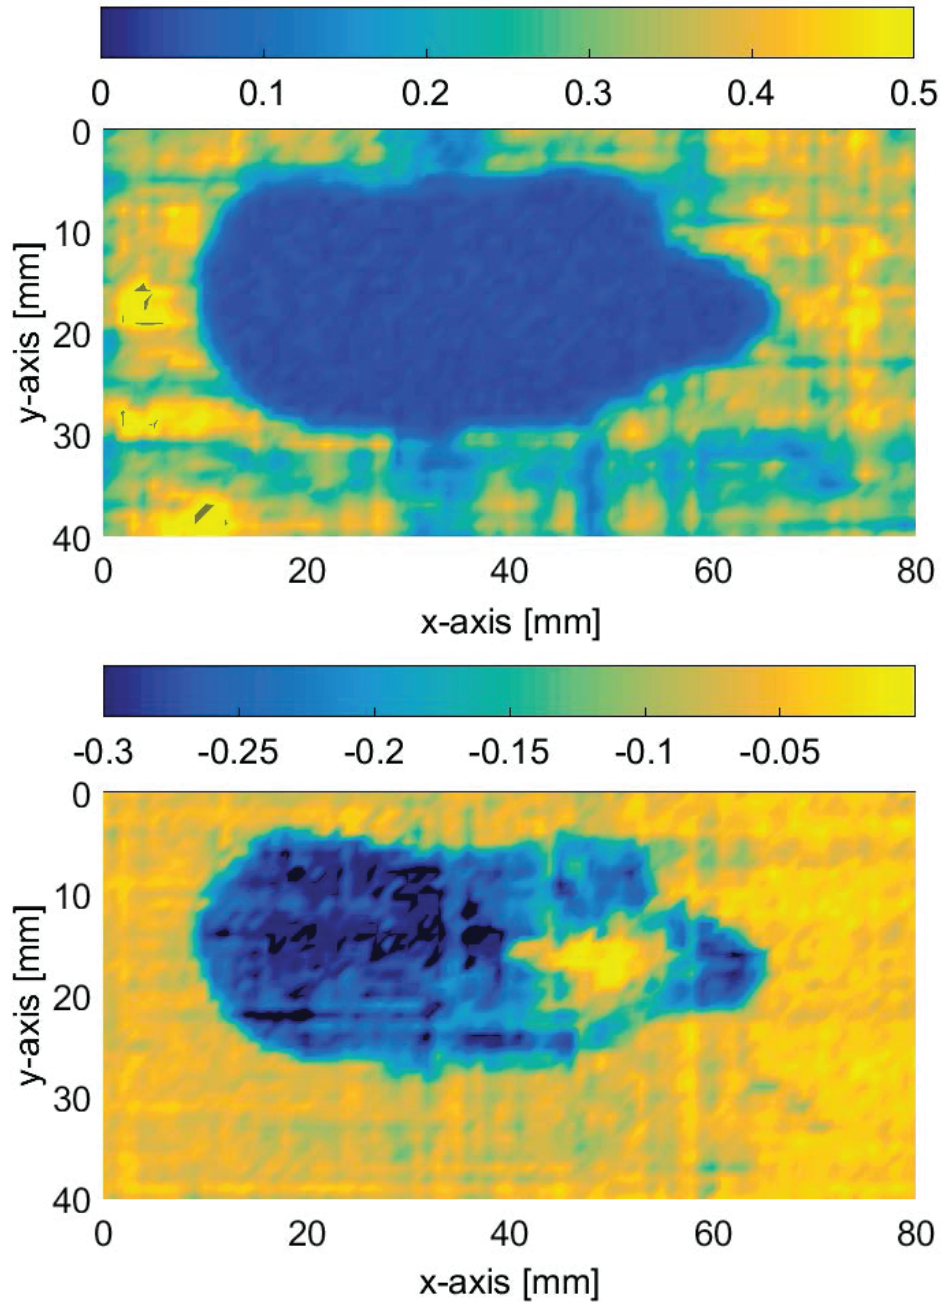
FIGURE 2. Ultrasonic C-scan images of damage in composite specimen; maximum amplitude of time-gated signal, 10 MHz immersion transducer, 1 mm step size; top: double-through transmission; bottom: pulse reflection.

The amplitudes of the double-through transmission and reflection C-scans of the composite specimen are shown in Fig. 2. The impact center was at approximately 50 mm in the x-direction and 20 mm in the y-direction. For the double-through transmission (Fig. 2 top) an area with distinctive low amplitude (dark blue) can be identified, extending about 60 mm in the x-direction and 25 mm in the y-direction. This indicates the delamination area, as the amplitude of the ultrasonic pulse transmitted twice across the delamination is significantly reduced. In the area around the delamination a pattern of higher amplitudes (yellow) can be observed. This pattern is linked to the specimen surface and internal structure, leading to variations in the ultrasonic transmission and reflection. Lines of low amplitude can be identified at 35 and 50 mm in the x-direction and about 35 mm in the y-direction, which could be linked to damage extending along the cross-ply fiber directions.

Figure 2 bottom shows the reflected amplitude (negative) of the second C-scan from the composite plate. The size and shape of the area of large negative amplitude matches well with the delamination observed for the double-through transmission above. The area of lower (negative) amplitude around 55 mm in the x-direction and 25 mm in the y-direction corresponds to a small indent visible from the drop-weight impact location (Fig. 1). It can be clearly observed that the delamination area is not symmetric around the center of the impact, extending significantly further to the left along the x-axis. The observed delamination shape exhibits a less regular pattern than previously found in literature [19]. Due to the chosen ultrasonic center frequency at 10 MHz, insufficient resolution in the thickness direction was available to obtain accurate depth information of the delamination damage. The area around the delamination again shows a pattern corresponding to the composite plate structure, with larger negative amplitude (40 - 70 mm in x-direction) potentially corresponding to different composite damage mechanisms.

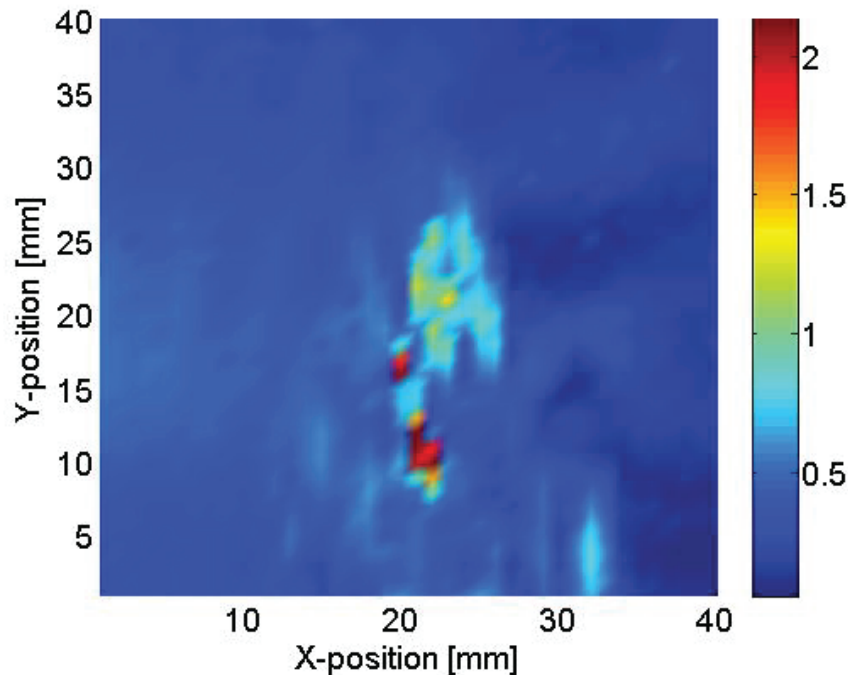
FIGURE 3. Amplitude of guided ultrasonic wave field scattered at impact damage in composite specimen, 100 kHz excitation, transducer at -30 mm in negative x-direction (incident wave propagation in positive x-direction), 1 mm step size, maximum amplitude of time trace at each scan position.

The amplitude of the guided ultrasonic wave field is shown in Fig. 3. Please note that the x- and y-directions are swapped as compared to Fig. 2. The fixed excitation transducer is placed at -30 mm in the negative x-direction, so that the incident wave is propagating in the positive x-direction. The guided wave measurements use a different experimental configuration compared to the immersion C-Scan, with a fixed excitation transducer and a laser head scanned over a grid with the same resolution, but centered on the impact location, to record the signal amplitude at each measurement point.

The incident wave field shows higher amplitude along the fiber direction (around $x = 0$ mm, $y = 20$ mm) as expected for an anisotropic composite plate. At the center of the impact damage ($x = 20$ mm, $y = 10$ -30 mm) very high amplitudes can be observed. This is the area where visually the small indent from the drop weight was observed and where the reflection immersion C-scan showed a change in the reflected ultrasonic amplitude. In addition to the delamination caused by the impact, further damage of the composite structure appears to have occurred. In literature, matrix cracking and fiber breakage at the impact center has been reported. An area with increased amplitude can be observed from approximately 10 to 32 mm in the x-direction and 0 to 30 mm in the y-direction. While no specific registration relative to the immersion C-scan measurements was done, this approximately coincides with the delamination area observed in Fig. 2 (rotated by 90 degrees). In the guided wave propagation direction behind the defect (from about $x = 30$ mm) lower amplitude of the guided wave can be observed. This is due to the scattering of the guided wave at the impact damage with limited energy propagated past the damage location. In general, good agreement of the damage extent with the immersion ultrasonic C-scans was observed. However, even though both are ultrasonic methods, the wave propagation direction and characteristics are different, so the two methods are sensitive to different aspects of the impact damage in composite structures.

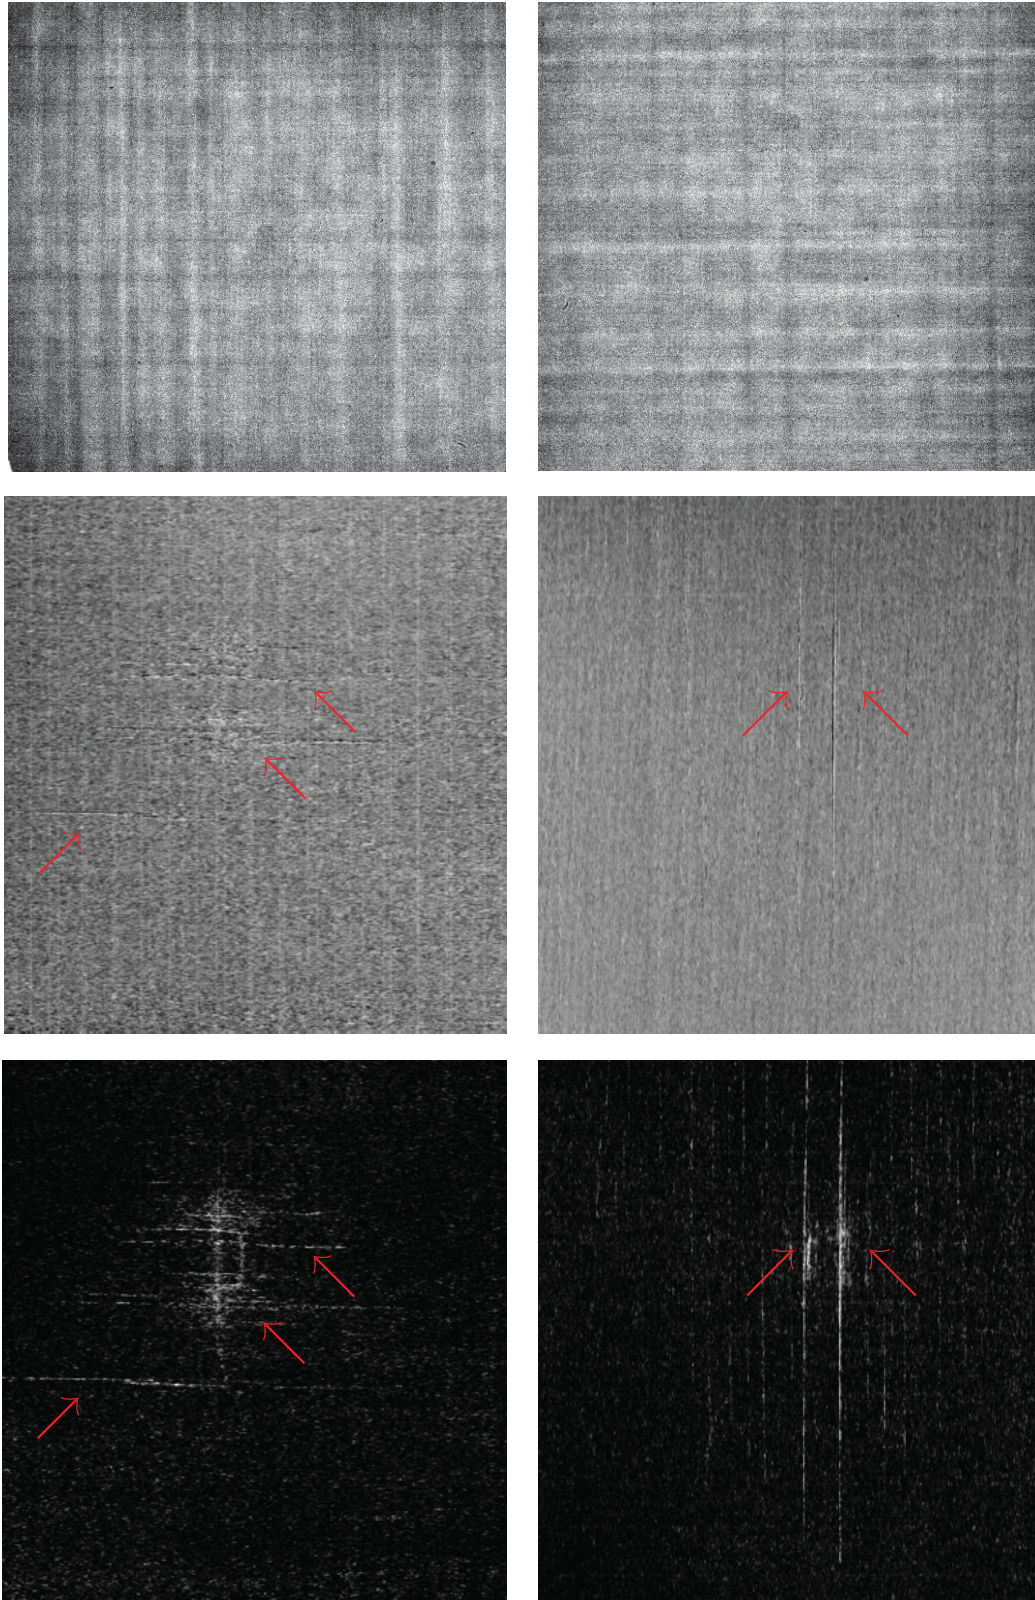
FIGURE 4. X-ray images of damage in composite specimen; top: conventional radiography; center: differential phase; bottom: dark-field image; left: horizontal; right: vertical rotation of specimen around X-ray beam axis.

The different images obtained from the EI X-ray phase contrast imaging are shown in Fig. 4, where conventional radiography (top), differential phase image (center) and dark-field image (bottom) are compared. Left and right columns show the composite specimen rotated by 90° as the EI X-ray phase contrast imaging is sensitive to the orientation of the damage relative to the masks' apertures, which are effectively long slits. The conventional radiography images (Fig. 4 top) show some of the inner structure of the composite specimen, but damage is not visible. It should be noted that no dye penetrant was used. Damage of the plate structure, close to the impact location center, can be seen in the dark-field images (Fig. 4 bottom) and is pointed out by the red arrows. Different damage extent along the respective fiber directions can be observed in the two dark-field images, which were acquired by rotating the specimen by 90° around the X-ray beam axis.

This demonstrates the various damage orientations along the direction of the fibers in the cross-ply structure, both in the width and length direction of the specimen. The EI imaging technique has the property that the signal appears modulated by the angle between specific sample features and the relative orientation of the optical mask apertures. Maximum signal is obtained when these are aligned, with minimum signal when orthogonal. The dependence of the sensitivity to the damage orientation could be further exploited to improve the characterization and modelling of the impact damage in composite plates. For different lay-up configuration, e.g., a quasi-isotropic plate, further measurements could easily be conducted in the +/- 45° fiber directions.

The longer damage is also visible in the differential phase image (Fig. 4 center), illustrated by the arrows. The visibility from the images is not as clear as for the dark-field images (Fig. 4 bottom) for this case of impact damage, and only features aligned with the direction of the aperture are visible. The X-ray EI images, especially the dark-field imaging, are sensitive to damage along the fiber directions aligned with the system aperture and typically on a smaller length scale than the ultrasonic images, which are to some degree limited by the ultrasonic wavelength.
