SEISMIC RESISTANCE OF TRADITIONAL TIMBER-FRAME HİMIŞ STRUCTURES IN TURKEY: A BRIEF OVERVIEW

Yasemin Didem AKTAŞ*

Epicentre Research Group, Civil, Environmental and Geomatic Engineering, University College London (UCL),
London, UK
y.aktas@ucl.ac.uk

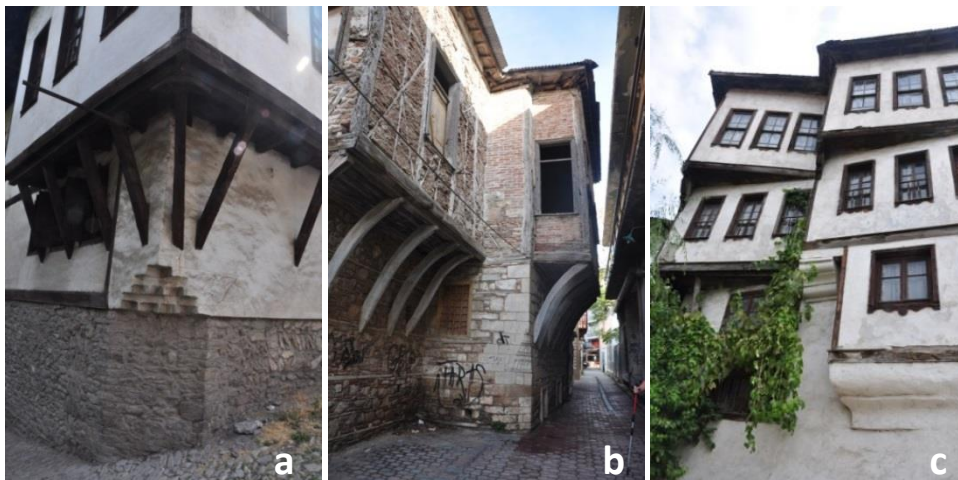
Figure 3: Braced projections from (a) Safranbolu, Turkey and (b) Chalkis, Greece (this concave variation is known as eliböğünde), and (c) simple cantilever projection from Safranbolu

Projections (jetties, *çıkma* in Turkish) are one of the most distinguishing features of *hımış* houses (Figure 3), which actually did not exist till late 16th century [1]; *vakfiyes* (Turkified from Arabic *wakfiy(y)a*, meaning deed documents issued for mortmain properties – *waqf*, in Turkish *vakıf* – managed under a religious, non-profit charity concept) suggest that in the 15-16th centuries most houses were single-storey [45]. When the multiple story housing became widespread, the projections lent themselves to making upper-storeys more spacious and regular in shape in contrast to often narrow and irregular ground-floor plan geometries, as well as to have a more complete view of the street via bay-windows located on the projections (*cumba* in Turkish) [46].

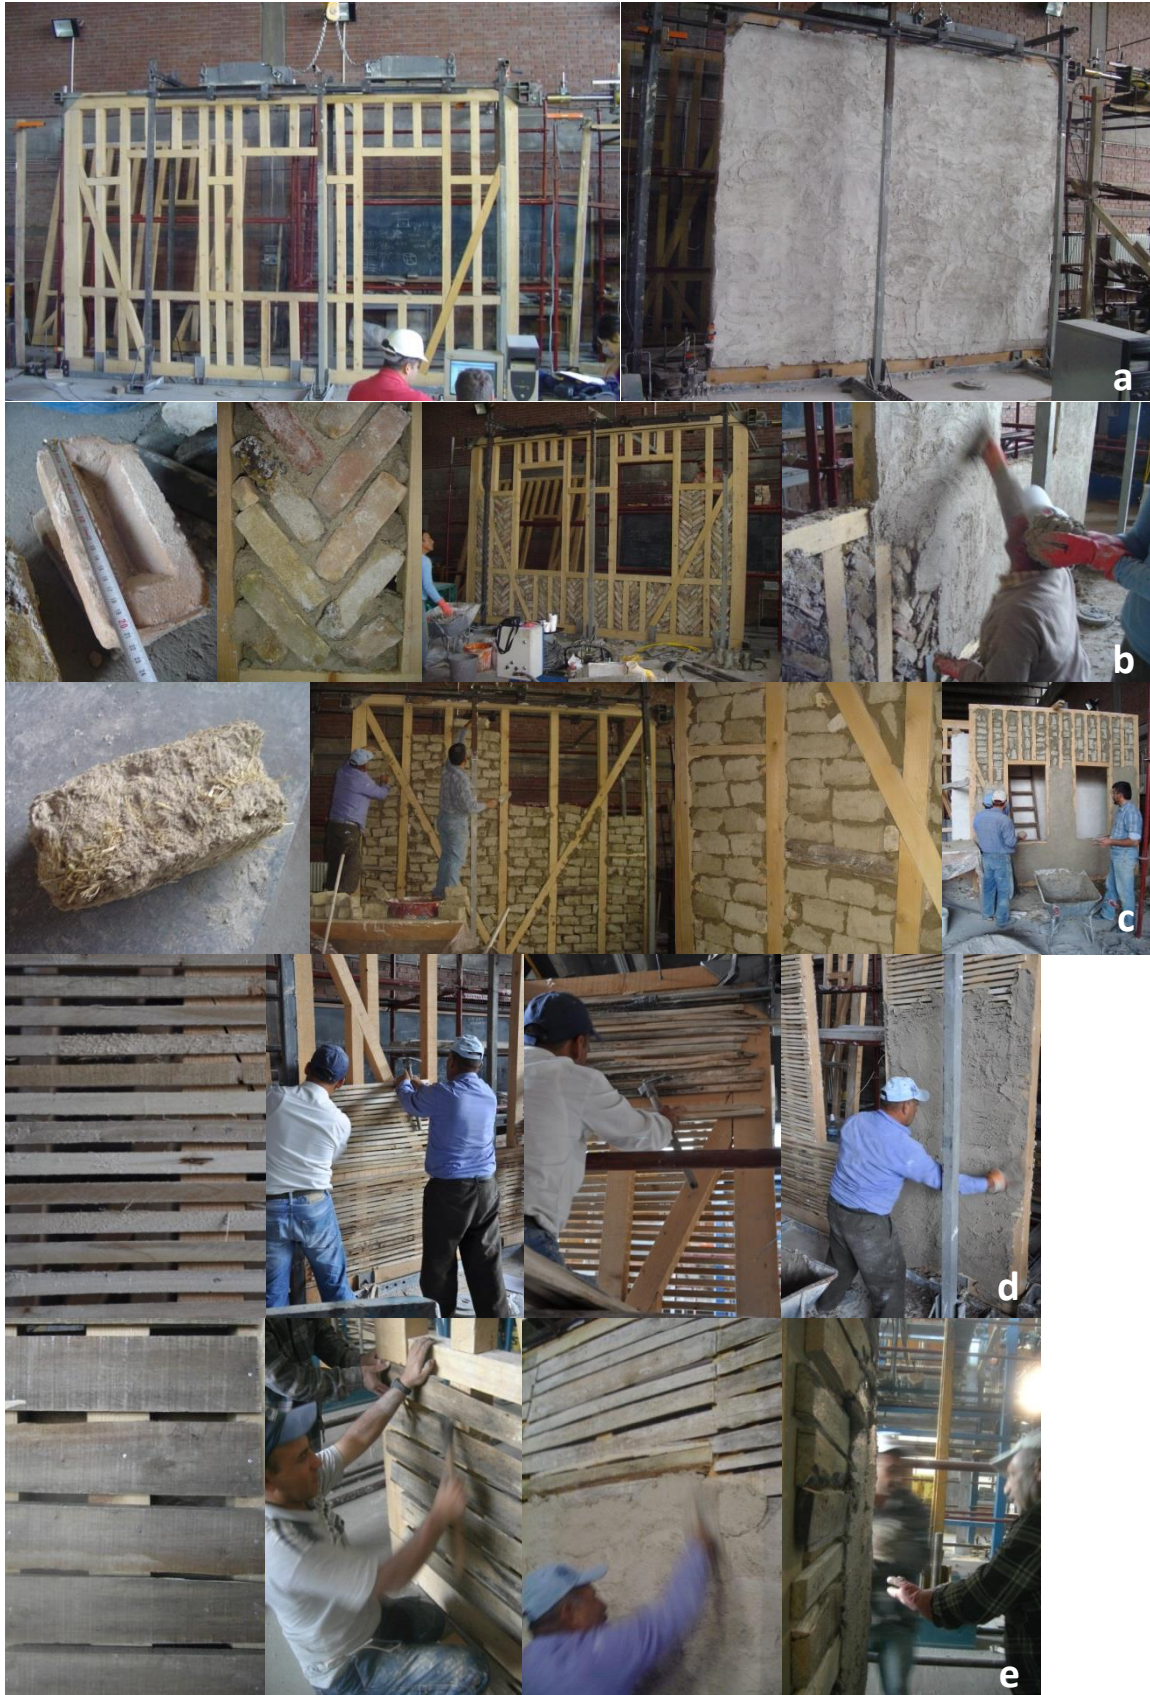
Figure 4: (a) Frame tests under reverse-cyclic lateral loading; (b) brick infill; (c) adobe infill; (d) *bağdadi* cladding; (e) *şamdolma* cladding.

laths, see Figure 4d&e, respectively). The findings from the testing scheme were reported in detail elsewhere (see [49-52]). In the following, certain structural features of *hımış* houses are further discussed in the light of the findings of the aforementioned testing scheme and other resources.
