Journal of the Institute of Civil Protection and Emergency Management

# ITALY'S AUGUST OF DISASTERS

by David Alexander

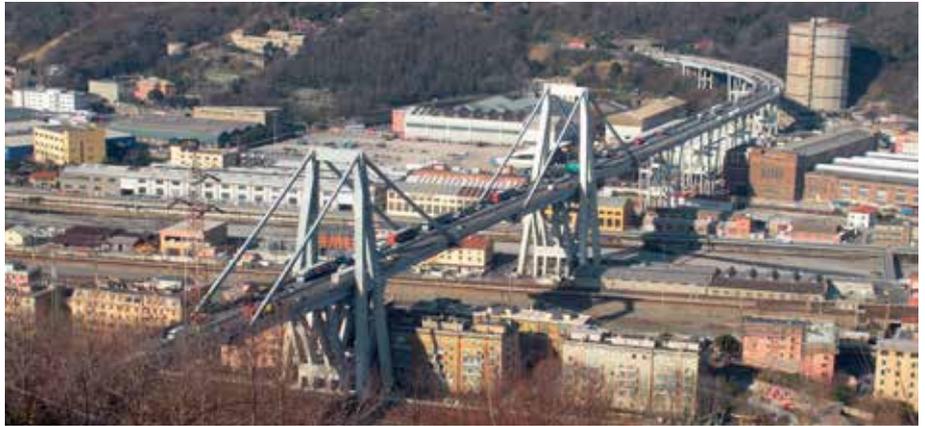
*The Polcevera Viaduct, or Morandi Bridge, in Genoa in 2012. Source: Bbruno, Wikimedia Commons.*

In August 2018 the most spectacular tragedy was the collapse of the Morandi Bridge. This structure, more correctly termed the Polcevera Viaduct, was designed by the

engineer Riccardo Morandi (b. Rome, 1902–1989), who was an expert in pre-stressed concrete. Morandi aimed to provide a design that married form and function while saving costs compared with more conventional steel suspension bridges. The main problem with this approach was that in the 1960s relatively little was known about processes of decay and weakening in reinforced concrete. Nor was it expected that traffic levels would increase as much as they did in subsequent decades. Morandi, however, was explicit in stating that the money saved on construction would have to be paid out in maintenance. He designed a similar, but much longer structure, the General Rafael Urdaneta Bridge in Maracaibo, Venezuela, which was inaugurated in 1962 and still stands. Five years later, the Genoa bridge was opened with a vivacious celebration of its avant garde modernity.

The suspension cables for these bridges are encased in concrete, which is, of course, a porous material. Stresses may remain the same, but bearing capacity may be weakened by corrosion, which at Genoa may have eaten up 20 per cent of the cable width. A combination of lightning strikes and traffic vibration would then lead to severing of the cables. At Genoa, the alarm was first raised in the 1990s, when studies were carried out with non-invasive sensors and finite-element modelling of bridge performance. As a result, part of the bridge (Tower no. 11) was retrofitted with steel reinforcements that duplicated the suspension cables. The rest was untouched, including Tower 9, which collapsed in 2018. In 2003 a leading politician loudly proclaimed that talk of structural failure of the bridge was 'a fairy-tale', but some engineers were nonetheless concerned. By 2017 the situation had become critical, but instead of following advice to close the bridge, the motorway authority drew up a plan to monitor displacements and design reinforcement measures. It was too little, too late.

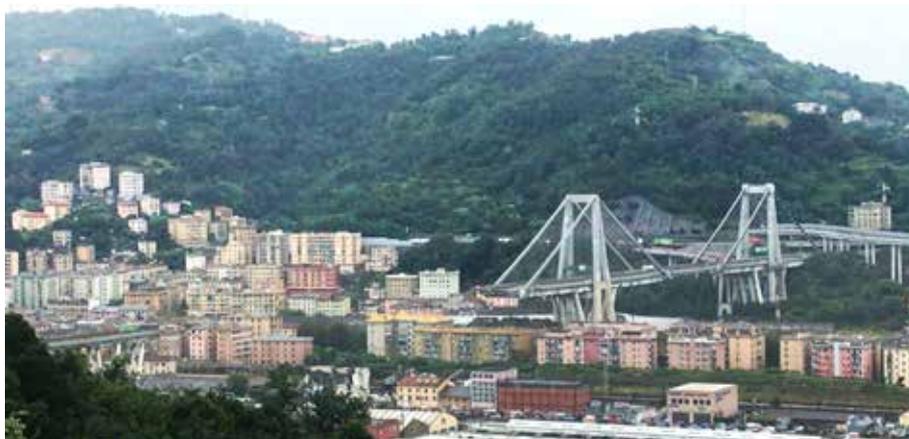
*The Morandi Bridge after the August 2018 collapse. Source: Salvatore1991, Wikimedia Commons.*

bridge at Ancona (Marche) in 2017 and the Fossano bridge at Cuneo in 2017. The Bologna motorway bridge collapse of August 2018 was mentioned above and had a different origin to the others. After the Genoa collapse, engineers noted that the Polcevera Viaduct had been built without redundancy in its robustness or ductility. However, they added that this was normal practice in the 1960s, in which little thought was given to phenomena such as micro-cracking in pre-stressed concrete.
