# Emilia Earthquake: the Seismic Performance of Precast RC Buildings

On 20<sup>th</sup> and 29<sup>th</sup> May 2012 two earthquakes of magnitude 5.9 and 5.8 ( $M_w$ ) occurred in the Emilia region (Northern Italy), one of the most developed industrial centers of the country. A complete photographic report collected in the epicentral zone shows the seismic vulnerability of precast structures, the damage to which is mainly caused by connection systems. Indeed, the main recorded damage is either the loss of support of structural horizontal elements, due to the failure of friction beam-to-column and roof-to-beam connections, or the collapse of the cladding panels, due to the failure of the panel-to-structure connections. The damage can be explained by the intensity of the recorded seismic event and by the exclusion of the epicentral region from the seismic areas recognized by the Italian building code up to 2003. Simple considerations related to the recorded acceleration spectra allow motivating the extensive damage due to the loss of support.

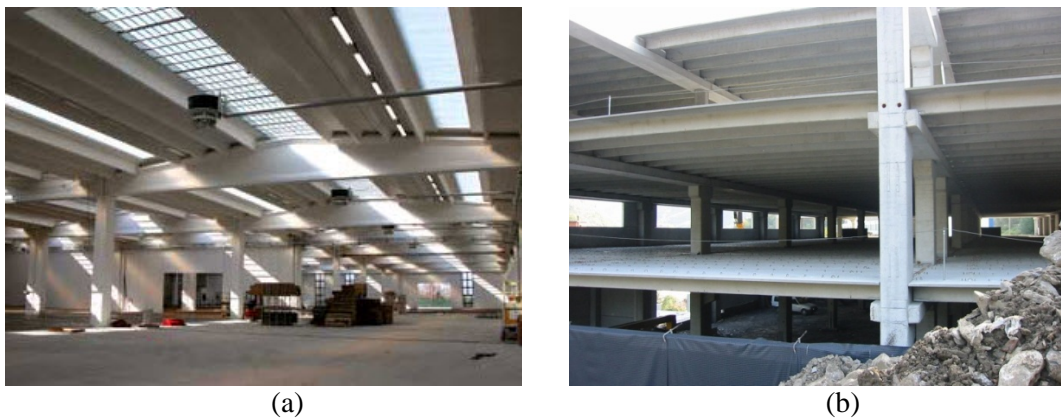
**Figure 1.** Examples of (a) single-story and (b) multi-story precast buildings

Since the end of the Second World War, precast structures have been widely used in Italy due to the several advantages of serial production of structural elements. Precast elements, produced in factories, are characterized by a more precise control, a better quality and a faster construction time than the cast-in-situ RC elements. In Italy, precast structures are mainly used in the industrial field, where buildings require wide space, i.e. large bays, and very regular plants, e.g. square or rectangular shape. Precast buildings can be classified according to different variables: the structural typology, the number of stories and the roof type. Three main structural typologies can be distinguished: panel structures, column structures and mixed structures. Depending on the number of stories, precast structures can be single-story “industrial” buildings (Figure 1a) and multi-story buildings (Figure 1b). Referring to the roof type, roof elements supported by beams with variable section (Figure 2a), continuous plane roof (Figure 2b), discontinuous plane roof (Figure 3a) and shed roof (Figure 3b) can be found.

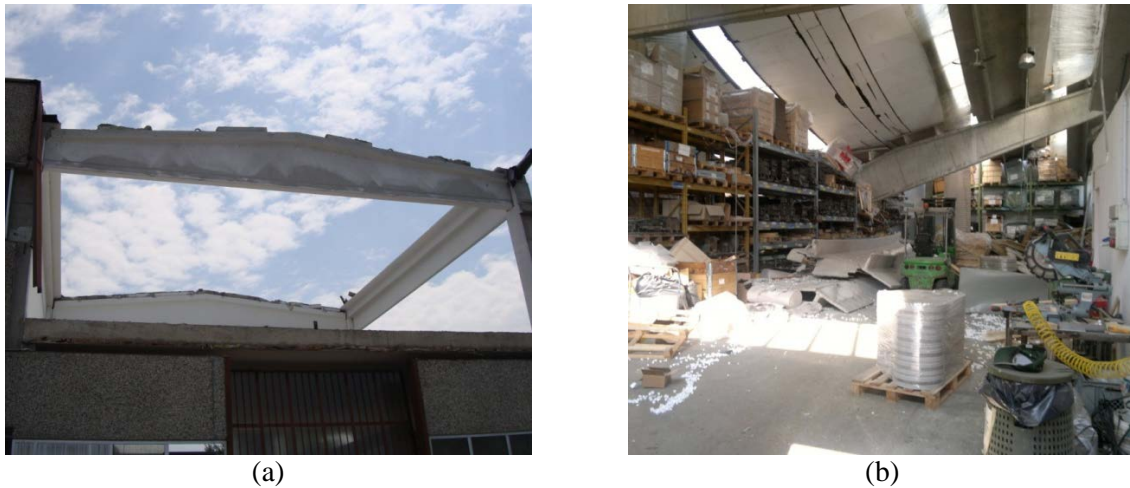
Most of the damaged precast buildings provides friction connections between horizontal elements (beams and roof elements) or between horizontal (beam) and vertical (columns) members. The lack of connection devices is the main cause of damage in precast structures, in which the low strength given by friction mechanism causes the loss of support of both roof elements from beams and beams from columns. The consequences are disastrous: Figure 5a shows the loss of support of the roof elements from the main beam due to the use of friction connections and a very limited support width. Figure 5b shows the loss of support of a beam from the column and the consequent collapse of the roof elements, causing the failure of the whole structure.

**Figure 5.** (a) Roof elements collapse due to the loss of support from main beam. (b) Loss of support of beam from column.

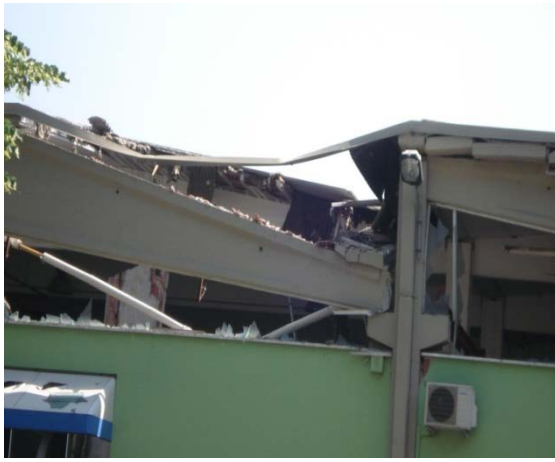
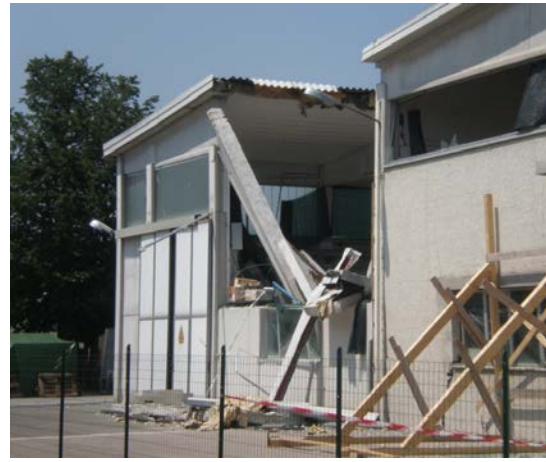
The lack of mechanical devices causes the loss of support of the beams from the columns also in Figure 6a. In other cases the loss of support causes the change of the beam restraints, that let the beam act as a cantilever, and make it collapse under the weight of the roof elements (Figure 6b). The vulnerability recorded in precast structures is certainly larger than the vulnerability exhibited by similar precast structures in Turkey after 1999 Kocaeli earthquake (Saatcioglu et al. 2001, Sezen et al. 2000); the main reason is the common presence of connections relying on friction in Emilia region, contrasting with the doweled connections used in Turkey.

**Figure 6.** (a) Loss of support of beam from column. (b) Collapse of main beam due to the loss of support on column.

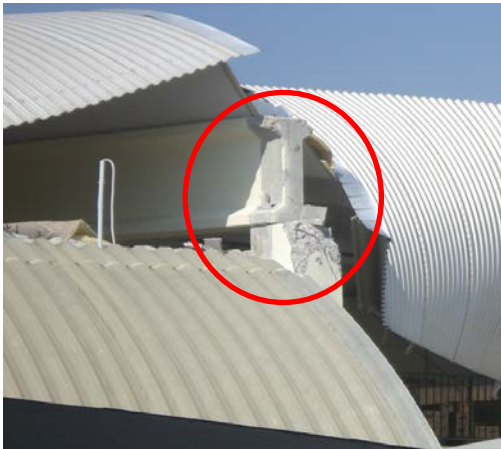
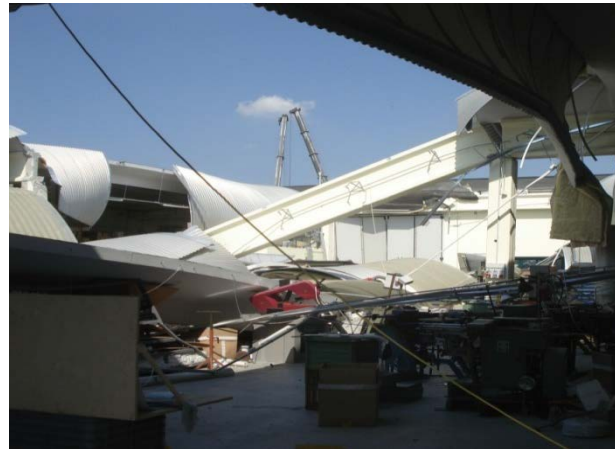
Some precast structures show the failure of the connections even in cases in which pin beam-to-column connections are used, due to the inadequacy of the connection design. Figure 7 represents a significant example of unsuitable design of the connection. The strength of the pin connection is evaluated in correspondence to the failure of the dowel; instead in Figure 7a, the spalling of concrete cover occurs before the yielding of the dowel, due to the small size of the cover and to the lack of dense stirrups close to the supporting zones. Consequently, it causes the collapse of the beam and roof elements which are supported by the beam (Figure 7b).

**Figure 7.** (a) Pinned beam-to-column connection failure and (b) consequent loss of support of the beam from column.

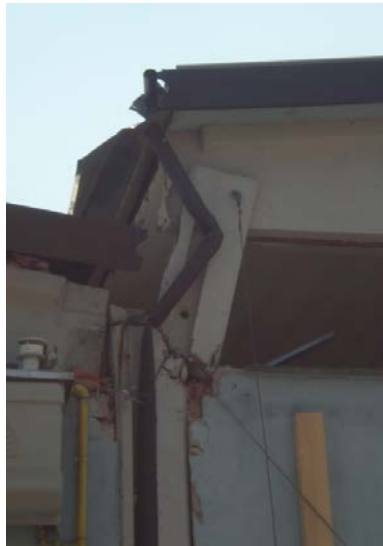
- loss of verticality due to a rotation in the foundation element (Figure 8a) caused by a possible inadequate column-to-foundation connection, even if this cause is not easily ascertainable unless a direct inspection of foundation is made;
- plastic hinge development at the column base: Figure 8b shows an incipient plastic hinge evidenced by extensive cracks at the base, and Figure 8c indicates a case of longitudinal bar buckling due to the visible lack of a proper stirrup spacing in the critical zone of the column.
- shear failure due to the interaction with traditional masonry infill systems (Figure 9).

**Figure 9.** Shear collapse of column due to the interaction with infill masonry panel.

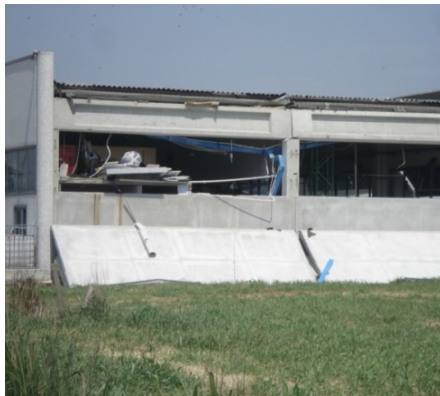
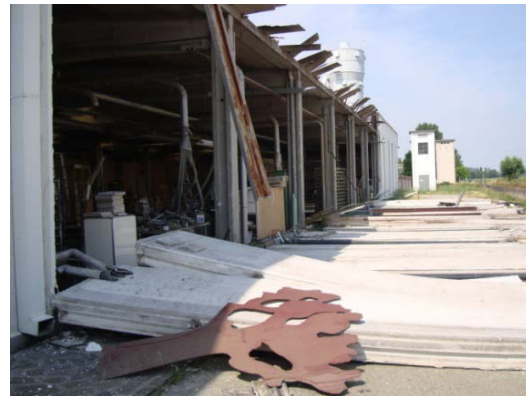
Precast buildings infill systems in Emilia region are mostly constituted by precast cladding panels. Horizontal (Figure 10a) and vertical (Figure 10b) panels collapse is the most frequent damage in precast buildings.

- a) the lack of seismic design in cladding panel-to-structural element connection devices;
- b) the pounding of roof elements, columns or other precast panels;
- c) the panel-to-structure interaction that causes additional lateral forces in the connection devices, not considered during the design process.

**Figure 10.** (a) Collapse of horizontal precast panels. (b) Collapse of vertical precast panels.

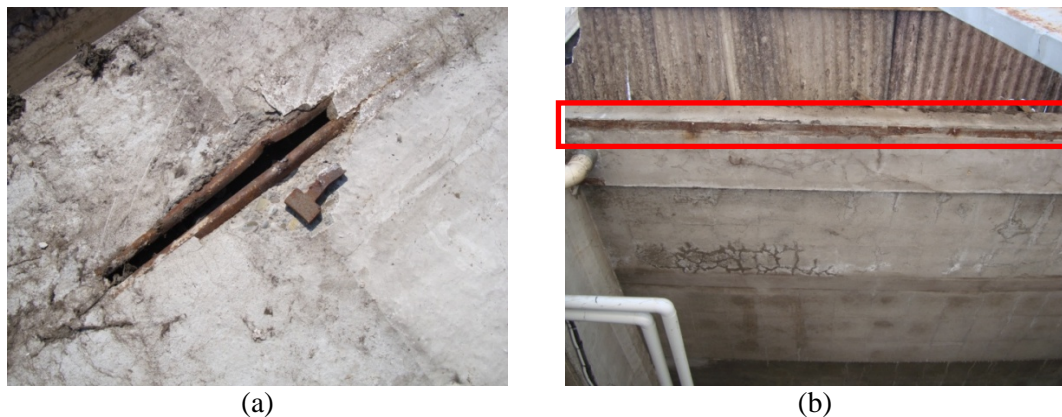
the steel angle plate that joints the panel to the structure (Figure 11b); details of the hammer head screw can be observed in Figure 11c. Figure 12 shows the collapse of a vertical panel-to-beam connection: in this case a particular connection device is used, i.e. a steel profile is embedded in the beam (highlighted in Figure 12b) and some hammer head elements are welded to the profile and inserted into the anchor channel of the vertical precast panels (Figure 12a). Under the seismic action the screw-to-profile welding fails and causes the collapse of the panels.

**Figure 12.** Collapse of vertical precast panel connection: (a) the anchor channel embedded in the panel and the failed hammer head element; (b) profile located in the beam which the hammer head elements are welded to.
